## Accident Blackspots on Rural Roads

## Safety Measures

## Effectiveness

Version 2011

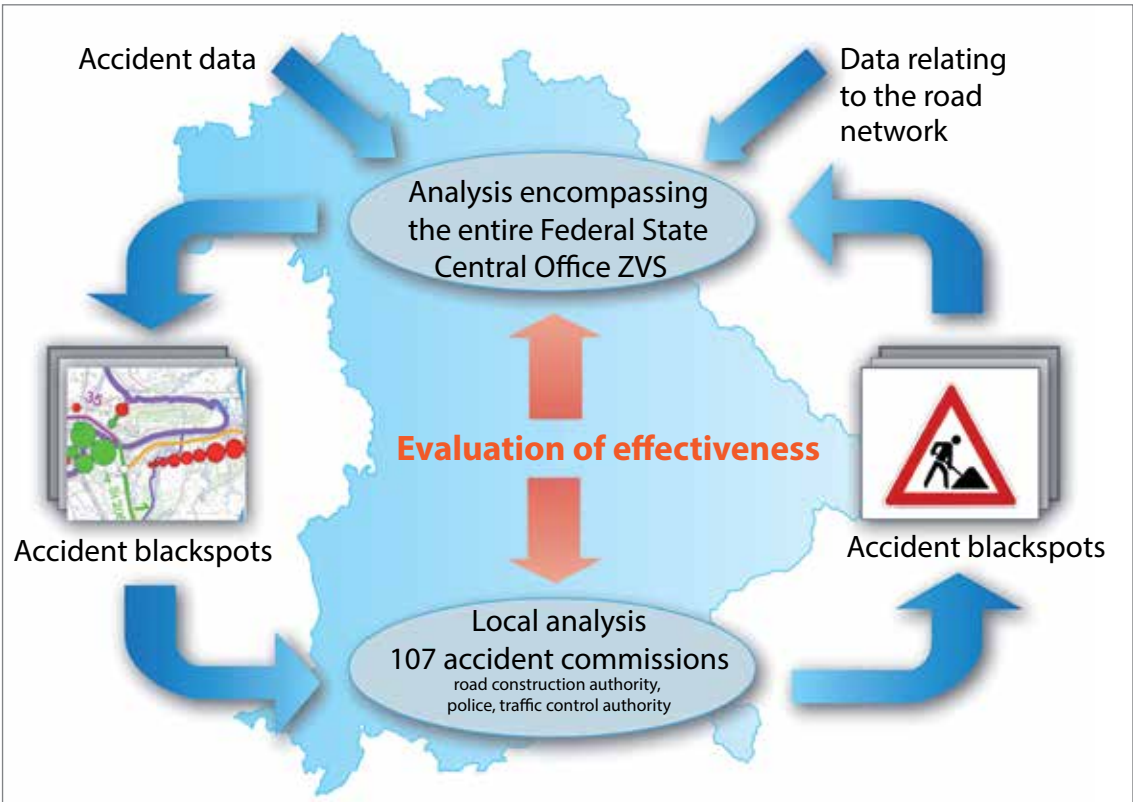
Figure 2: Schematic representation of the procedure for eliminating accident blackspots on regional roads in Bavaria

A total of 107 accident commissions for regional roads in Bavaria were established in 2000. Safety-improving measures at accident blackspots performed in the scope of ongoing projects, e.g. conservation measures, complement the remedial measures initiated by the accident commissions. In order to be able to better analyse the complex interactions between the incidence of accidents, accident causes and remedial measures including their effectiveness, all relevant information relating to accident blackspots is collected by the accident commissions and stored in a central database. This data management strategy substantially facilitates the documentation of implemented improvement measures at accident blackspots. In addition, it constitutes the basis for the effectiveness evaluation of these measures throughout Bavaria (see figure 2).

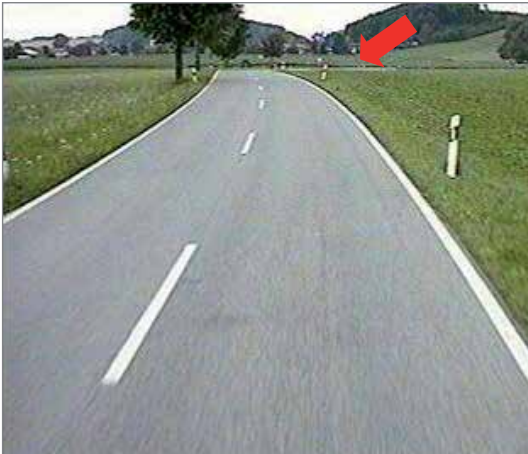
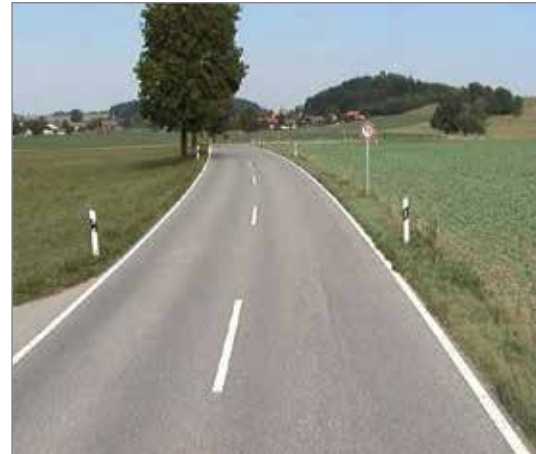
The intersection was hard to see. High speeds on the major road made it difficult to turn into the road (short time gaps).

The speed limit reduces the speed level before the intersection and creates longer time gaps for drivers turning (left) into the minor road.

**BUT:** A left-turn lane is still lacking.

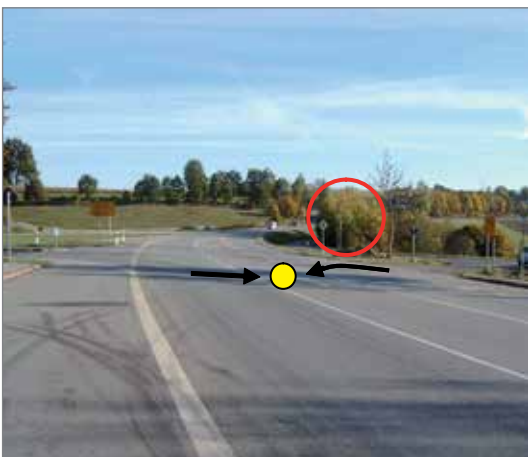
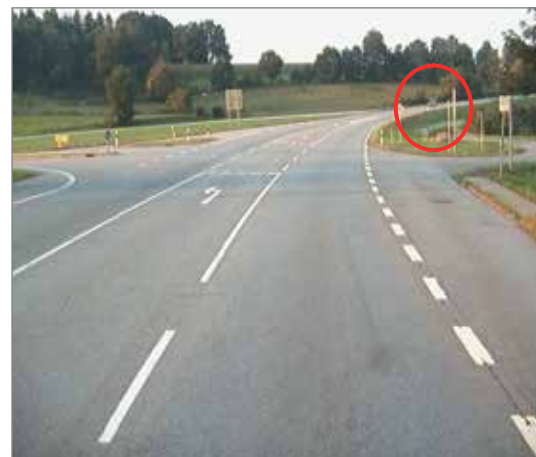
The vegetation on the side of the road's bend limited the visibility of vehicles coming from the direction of the minor road so that drivers concentrated on gaps between the vehicles in the flow on the major road and collided with oncoming vehicles when turning left.

Cutting back the vegetation significantly improved the visibility situation at the intersection.

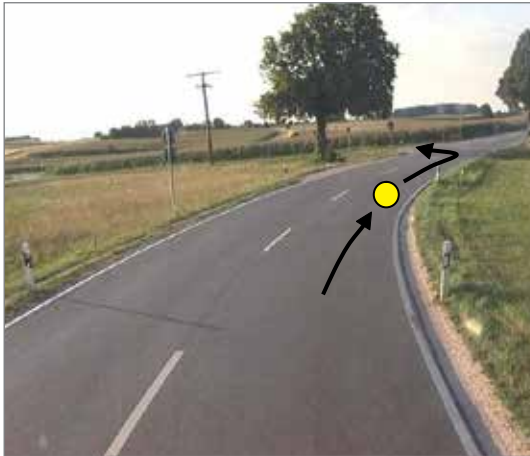
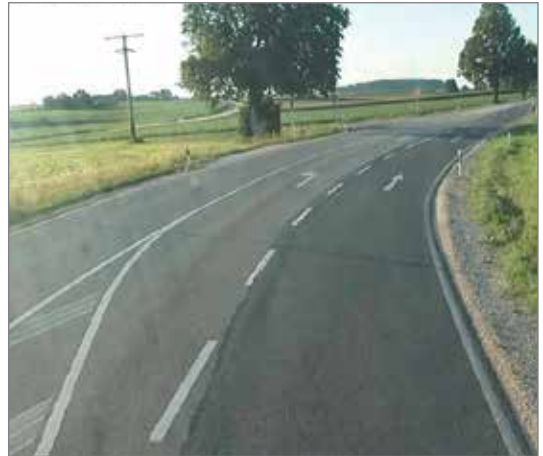
Since the intersection was hard to see, drivers recognized only very late that drivers in front of them intended to turn left. This resulted in rear-end collisions.

The added left-turn lane improves the visibility of the intersection on the major road and enables left turns without any danger to following straight-through traffic.

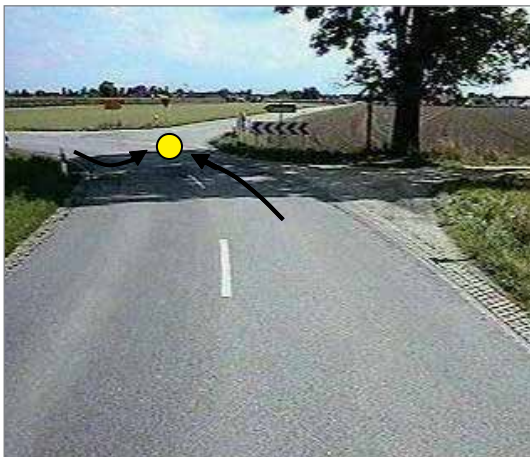
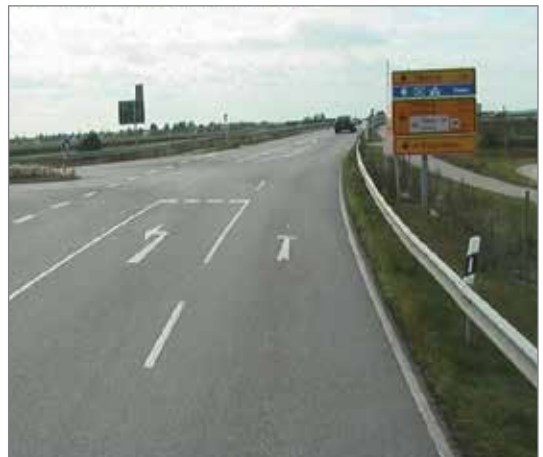
The minor road was connected to the major road in the outer bend. There was no left-turn lane. Drivers on the major road saw left turning vehicles only very late which promoted turning accidents.

The remodelling of the intersection according to the regulations including a modified right of way creates an unambiguous right of way situation.

**BUT:** The signpost is not installed according to the regulations.

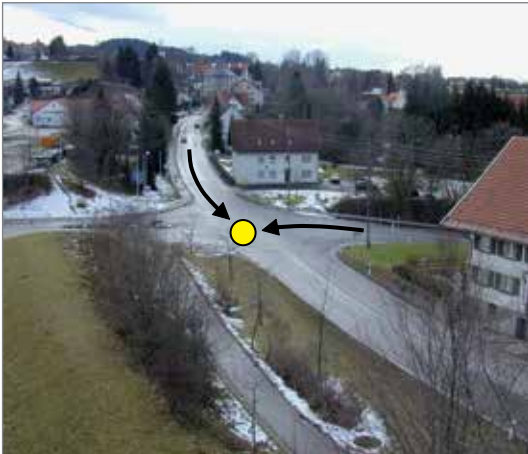
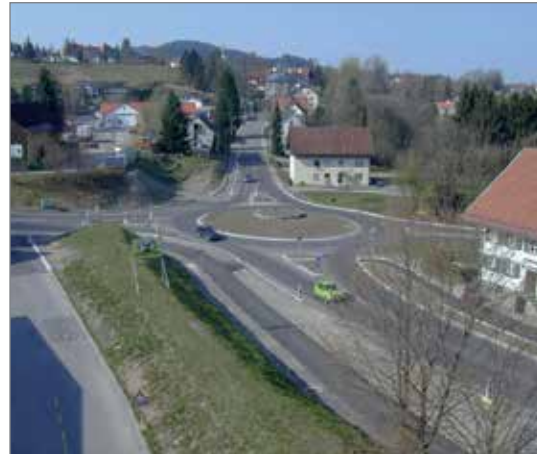
The bending priority road was ignored resulting in accidents with following or turning vehicles.

A roundabout unambiguously determines the right of way situation and reduces the speed level and thus the severity of accidents.  
**BUT:** Destination signs on the centre island are still lacking.

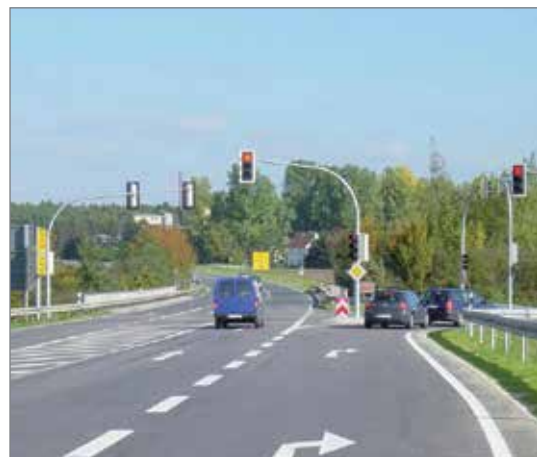
Drivers turning left into the minor road ignored the right of way and collided with oncoming or right-turning traffic.

Traffic lights ensure conflict-free turning.

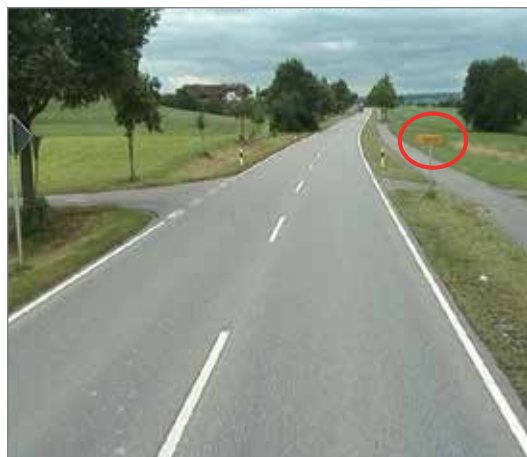
The intersection was hard to see and, together with the straight road layout, this promoted high driving speeds resulting in severe accidents with turning-off vehicles.

The installed signpost improves the visibility of the intersection on the major road.

**BUT:** The font size of the signpost is not sufficient. A left-turning lane is still lacking.

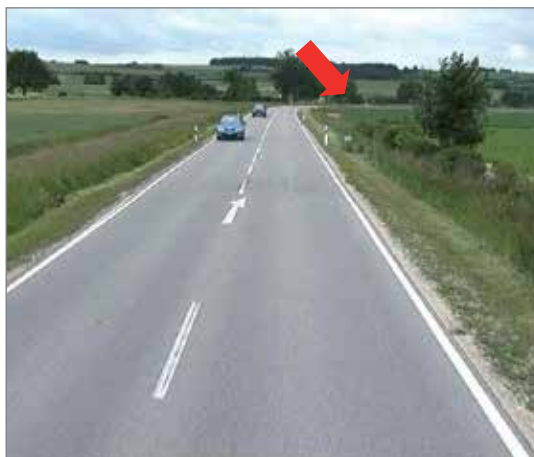
The intersection was hard to see. Drivers overtook other vehicles before the intersection, which caused them to recognize vehicles turning too late and the following traffic collided with the vehicle's rear end.

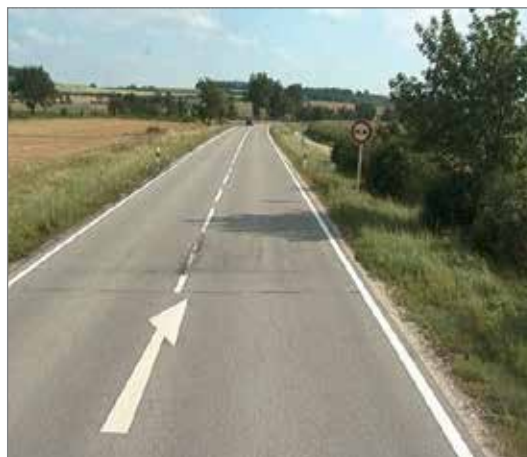
The ban on overtaking prohibits overtaking before the intersection.

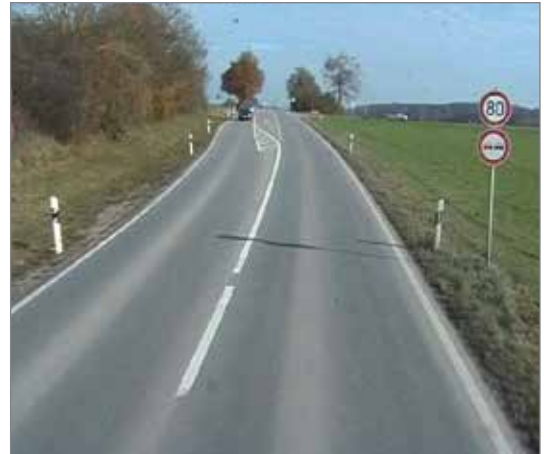
High speeds on the major road made it difficult to turn into the major road from the minor road (short time gaps) causing the vehicles turning into the road to collide with vehicles having the right of way.

The limitation of the maximum permissible speed reduces the speed level at the intersection and increases the time gaps for turning into the major road.

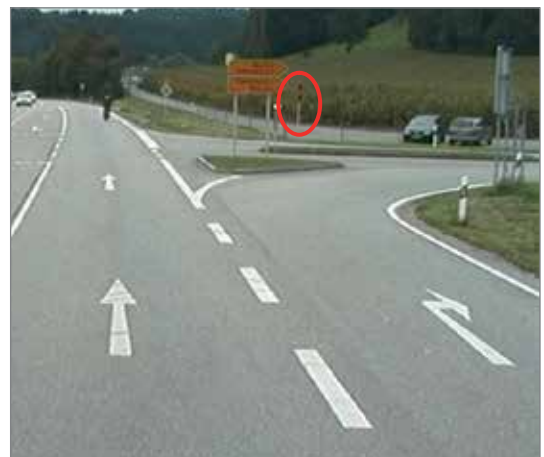
The obligation to stop on the minor road was often ignored with drivers turning into the major road without stopping resulting in a collision with vehicles having the right of way.

A stop sign indicates the obligation to stop on the minor road.

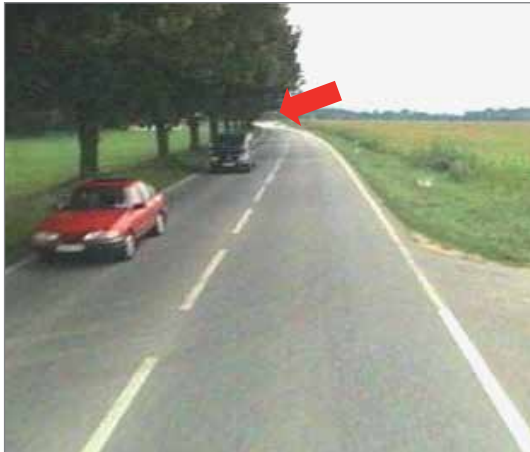
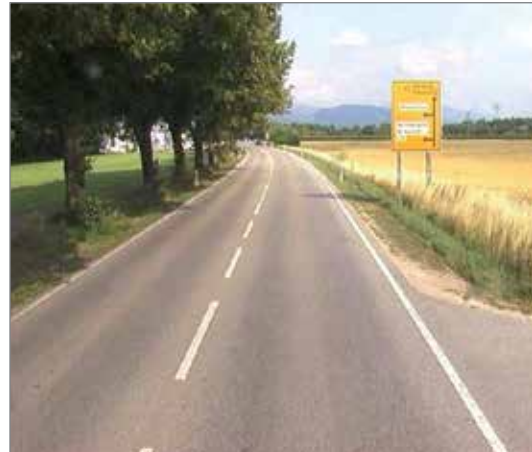
Since the intersection was hard to see, drivers drove too fast in the intersection area which made it difficult for vehicles coming from the minor road to turn into the major road (short time gaps in the main flow).

The installed signpost gives advance warning of the intersections.  
**BUT:** A left-turning lane is lacking and the row of trees still obscures the intersection and the vehicles in the main flow.

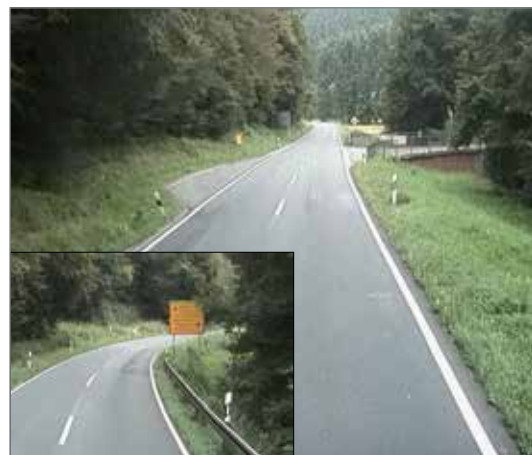
The junction that is located after a bend was not visible from the major road. The destination sign with arrows indicating the directions was installed directly before the intersection and additionally limited the visibility of drivers turning into the major road causing them to collide with vehicles having the right of way.

The destination sign with arrows indicating the directions is located before the bend and signals the intersection well in advance. This also improved the visibility of drivers turning into the major road.  
**BUT:** A tree is already obscuring the signpost. Visibility of drivers turning into the major road is still limited by the handrail of the bridge.

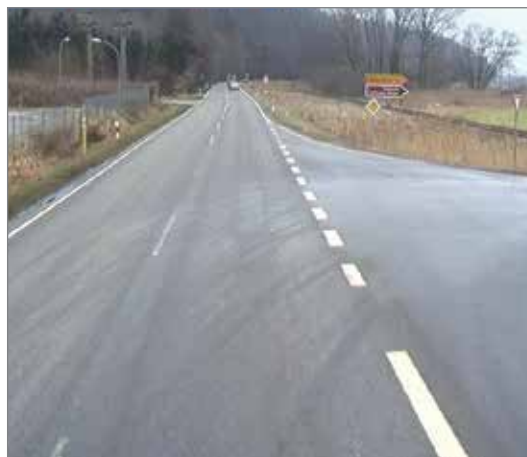
The stop line was renewed to signal drivers turning into the major road in a clearer way that they are obliged to stop.

**BUT:** A channelizing island (droplet shape) on the minor road is still lacking. The condition of the centre marking is in need of improvement.

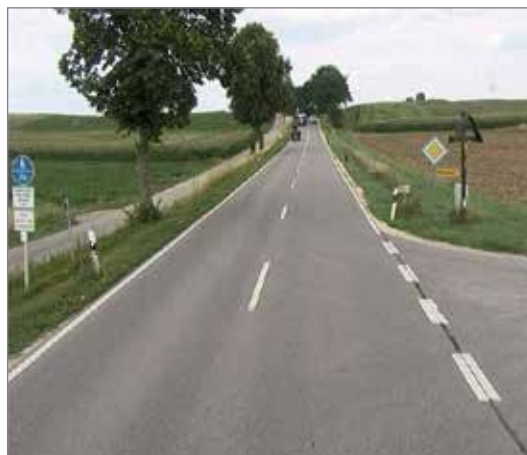
The stop line was no longer clearly visible causing vehicles to turn into the priority road without stopping and colliding with vehicles having the right of way.

The renewed stop line shows drivers turning into the major road that they are obliged to stop.

**BUT:** A channelizing island (droplet shape) on the minor road is still lacking.

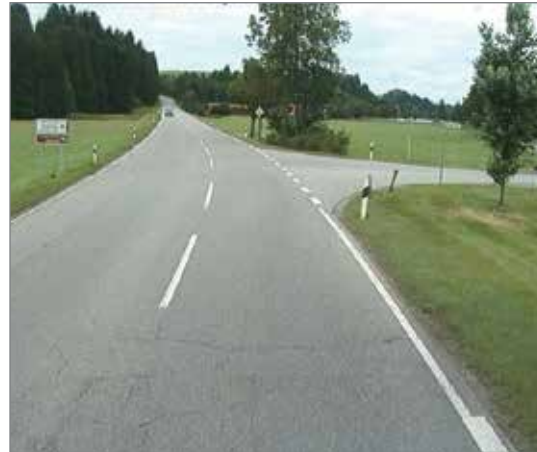
The visibility splay (range of vision required for a driver to safely turn into a major road from a stop) at the intersection was insufficient for both passenger vehicles and lorries. Accidents with vehicles having the right of way occurred as vehicles turned into the major road despite of bad visibility.

Obstructions reducing visibility for traffic turning into the major road were removed by optimising the installation sites of the signs.

**BUT:** A channelizing island (droplet shape) on the minor road is still lacking. The signposts are not installed according to the regulations.

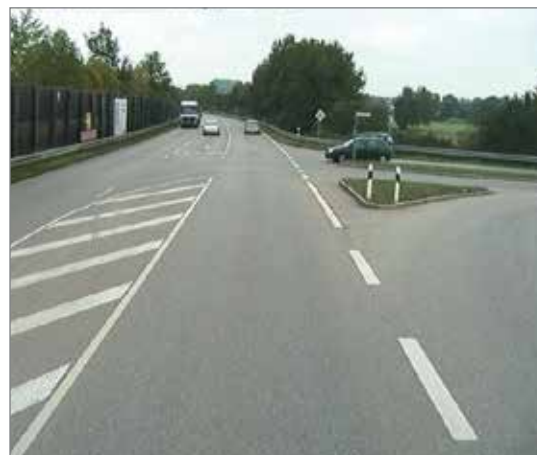
The visibility splay (range of vision required for a driver to safely turn into a major road from a stop) at the intersection was insufficient for passenger vehicles. Accidents with vehicles having the right of way occurred as vehicles turned into the major road despite of bad visibility.

Visibility for traffic turning into the major road was improved by replacing the marker board with posts.

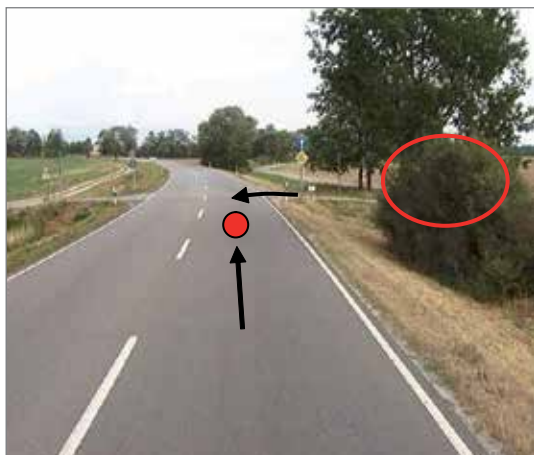
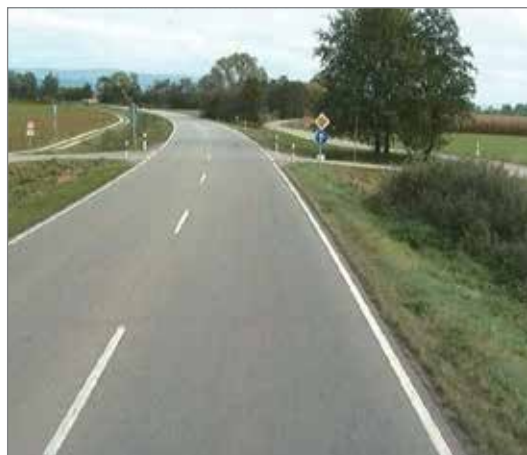
The visibility splay (range of vision required for a driver to safely turn into a major road from a stop) at the intersection was insufficient. Accidents with vehicles having the right of way occurred as vehicles turned into the major road despite of bad visibility.

Visibility for traffic turning into the major road was improved by cutting back the vegetation. **BUT:** The vegetation has to be cut back at regular intervals.

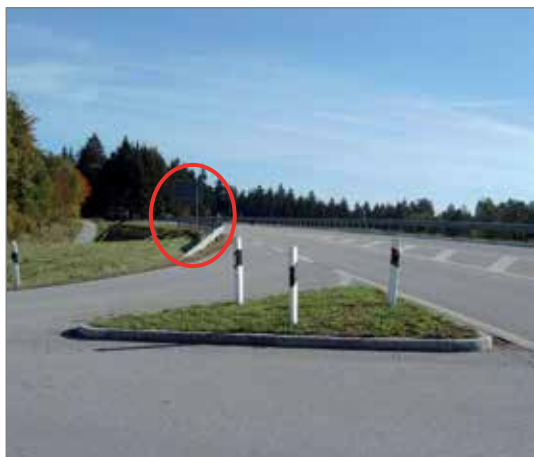
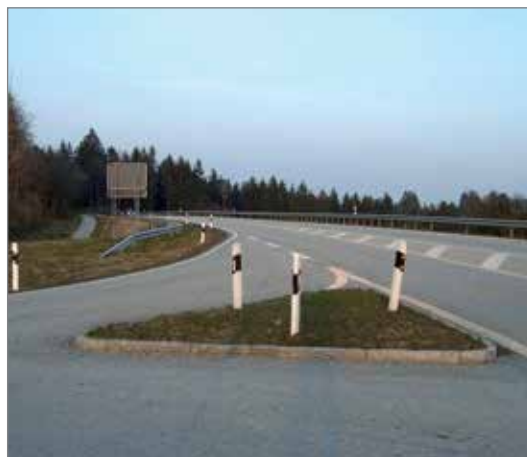
The visibility splay (range of vision required for a driver to safely turn into a major road from a stop) at the intersection was insufficient. Accidents with vehicles having the right of way occurred as vehicles turned into the major road despite of bad visibility.

The steel crash barrier and the signs were set back from the edge of the road, which improves the visibility for traffic turning into the major road.

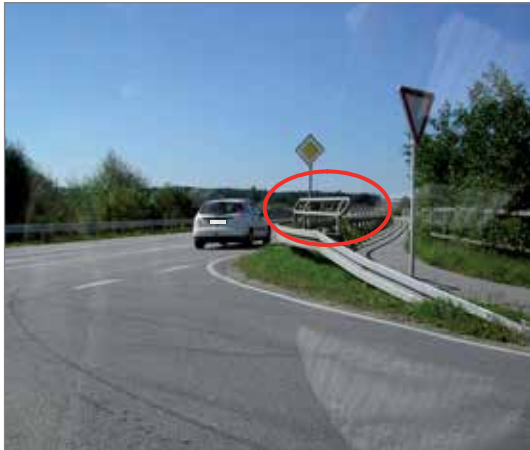
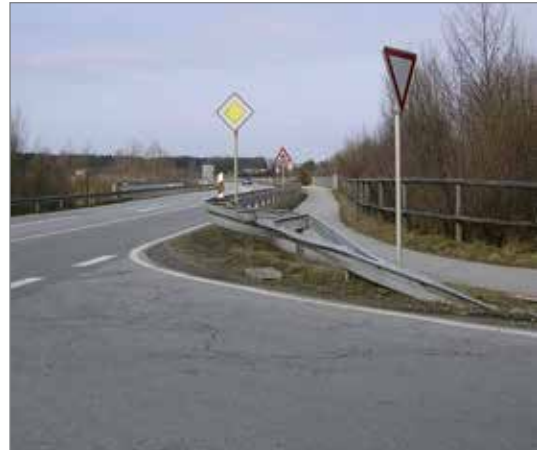
The visibility splay (range of vision required for a driver to safely turn into a major road from a stop) at the intersection was insufficient for passenger vehicles. Accidents with vehicles having the right of way occurred as vehicles turned into the major road despite of bad visibility.

Visibility for traffic turning into the major road was improved by removing the vertical extension rail.

**BUT:** The steel crash barrier is in a poor condition. The protection of cyclists is no longer guaranteed.

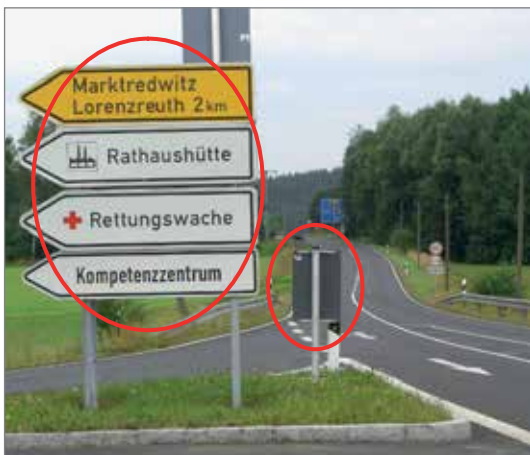
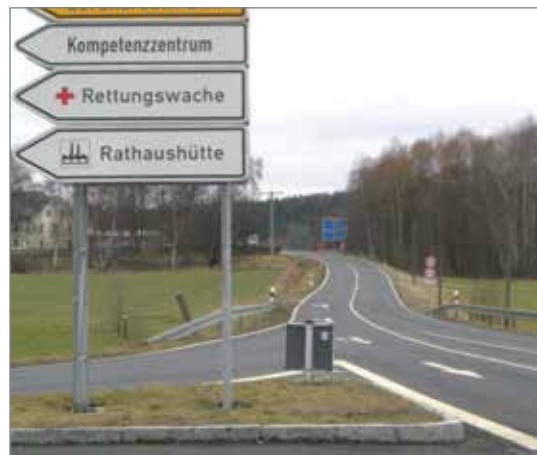
The visibility splay (range of vision required for a driver to safely turn into a major road from a stop) at the intersection was insufficient. Accidents with vehicles having the right of way occurred as vehicles turned into the major road despite of bad visibility.

Visibility for traffic turning into the major road was improved by moving the signposts up, lowering the marker board and removing the marker post.

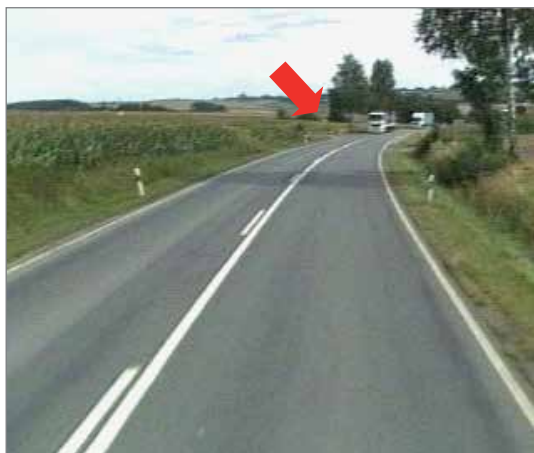
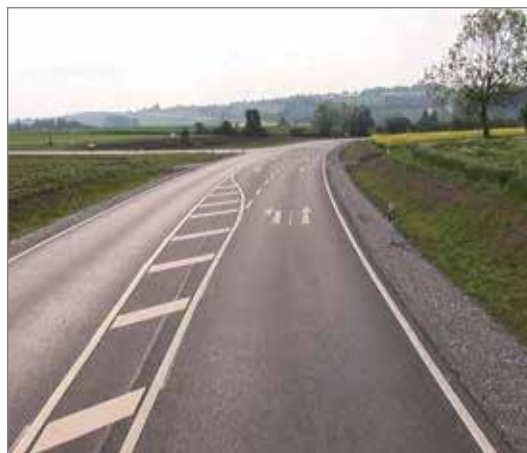
Since the intersection was hard to see, drivers drove too fast in the intersection area which made it difficult for vehicles coming from the minor road to turn into the major road (short time gaps in the main flow).

The added left-turn lane improves the visibility of the intersection.

**BUT:** A channelizing island (droplet shape) on the minor road and signposting is still lacking.

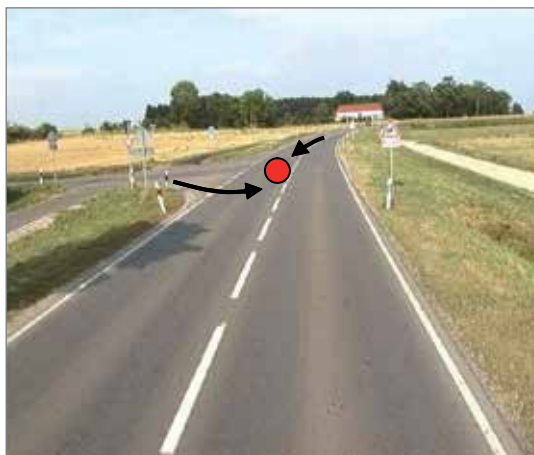
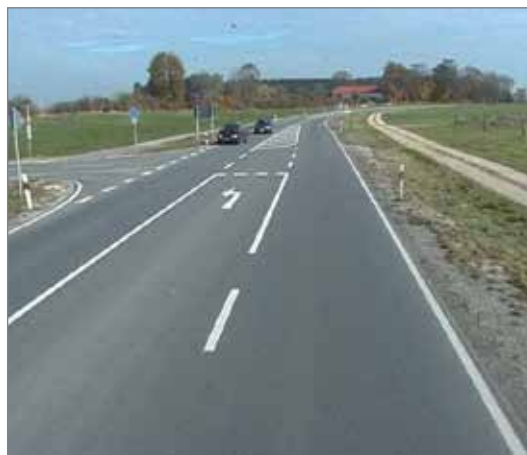
The intersection was hard to see in the dark. In addition, drivers drove too fast, which made it difficult for vehicles coming from the minor road to turn into the major road (short time gaps in the main flow).

The added left-turn lane improves the visibility of the intersection, especially in the dark.

**BUT:** A channelizing island (droplet shape) on the minor road is still lacking.

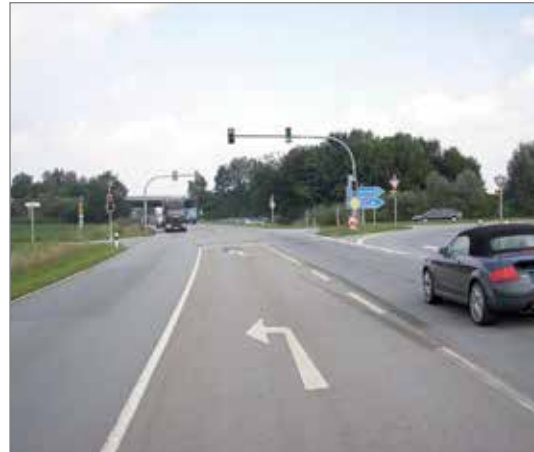
High traffic volumes on the major road made it difficult to turn into/cross the major road coming from the minor road (short time gaps).

A traffic light system provides sufficiently long time gaps in the main flow for safe turning into/crossing of the major road. In addition, the separate left-turn phase provides increased safety when turning.

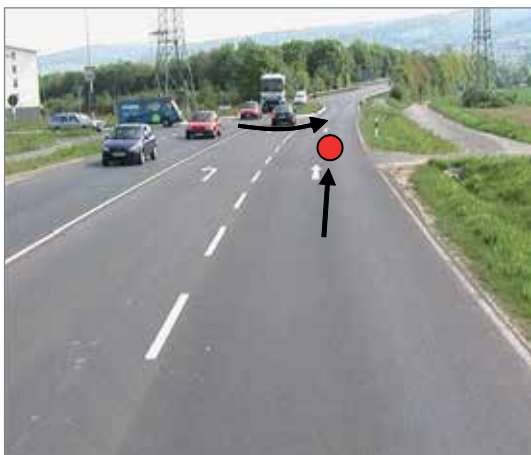
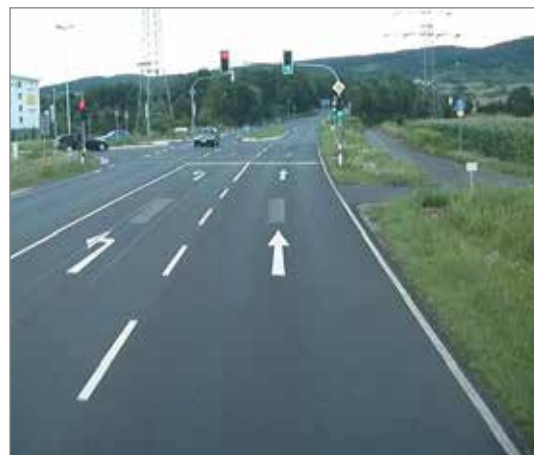
High traffic volumes on the major road made it difficult to turn left into the main flow (short time gaps).

A traffic light system provides sufficiently long time gaps in the main flow for safe turning into/crossing of the major road from the low-traffic minor road. At the same time, the traffic-actuated light signal control system provides for high throughput.

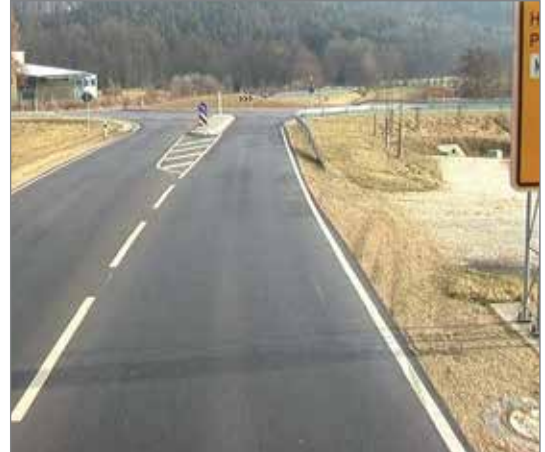
Crossing on the open road was allowed. Increased speed levels led to accidents with severe side collisions at the intersection when turning into/crossing the major road.

The conversion into a roundabout reduces the speed level at the intersection and makes turning into/crossing the major road easier (reduction of conflict points).

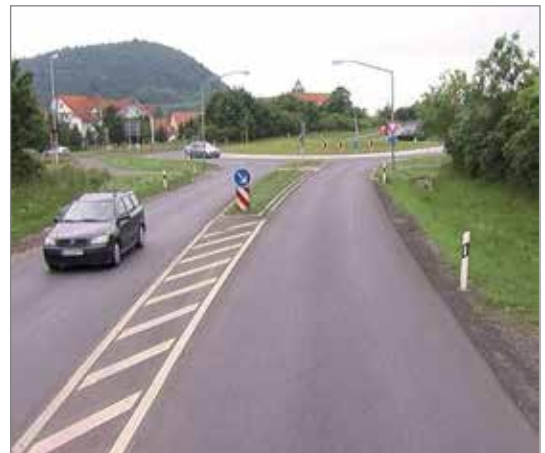
The conversion into a roundabout reduces the speed level at the intersection and makes turning into/crossing the major road easier. The lighting of the roundabout, especially outside of lit built-up areas ensures better visibility at night.

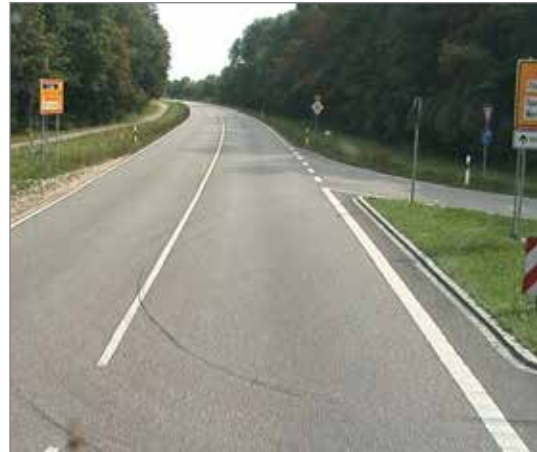
A junction opposite the minor road incited drivers to cross the major road in violation of the crossing ban. Illegal crossing manoeuvres led to accidents with vehicles having the right of way.

Thanks to the closed access the major road can no longer be crossed.  
**BUT:** Illegal turning manoeuvres to change direction are still possible and have been observed.

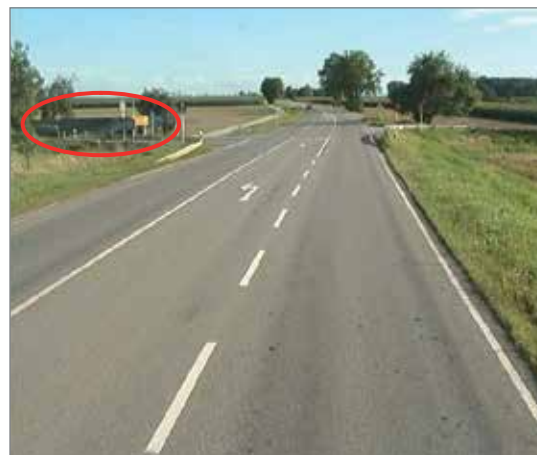
The range of vision of the traffic turning into the major road was very wide inducing drivers to misjudge distances and speeds, not least due to their own high speeds. Turning into the major road without stopping at the stop line led to severe accidents with vehicles having the right of way.

The screen "forces" road users turning into the major road to approach the intersection at a reduced speed and, thus, to pay increased attention at the intersection.

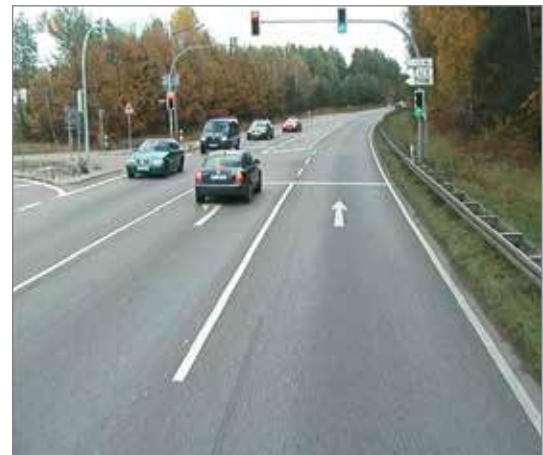
Traffic lights with separate left-turn phase clearly separates the traffic flow and ensures fast and safe turning.

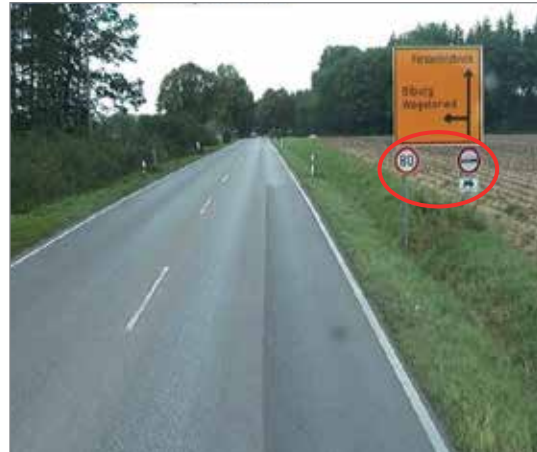
Since the intersection was hard to see, drivers only recognized slow vehicles in front of them very late. This caused rear-end collisions.

The new signpost gives advance warning of the intersection.

**BUT:** A left-turn lane is still lacking. In addition, the signposting is not installed according to regulations.

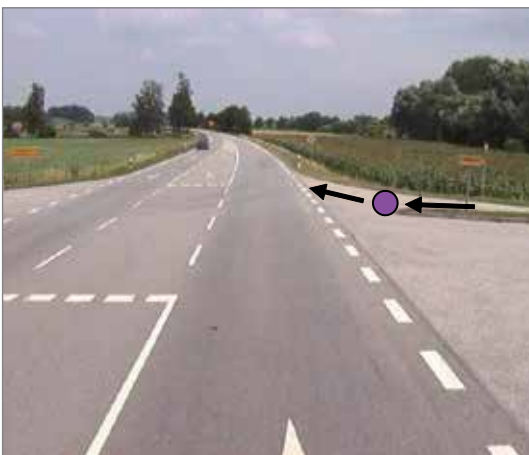
Problem

The large waiting area on the minor road incited drivers to enter the major road too quickly, which caused conflicts when decelerating and resulted in rear-end collisions.

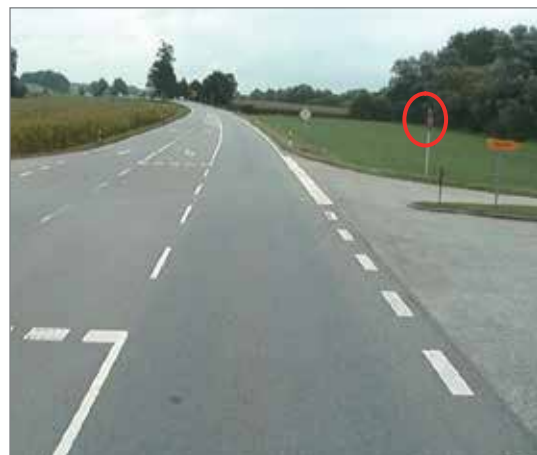
Measure

A stop sign indicates the obligation to stop on the minor road and prohibits entering without stopping at the stop line.

**BUT:** The entry area is still too wide.

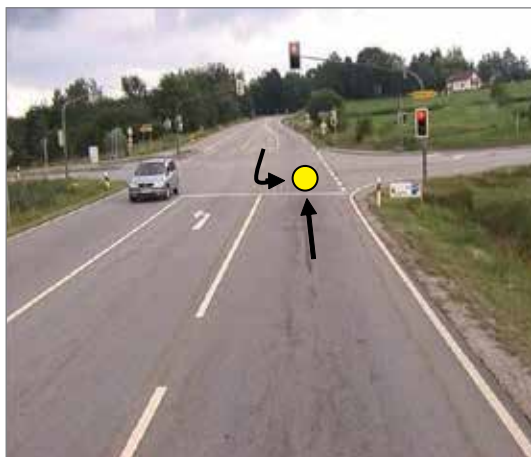
Problem

There was no separate phase for vehicles turning left, which promoted accidents when turning left.

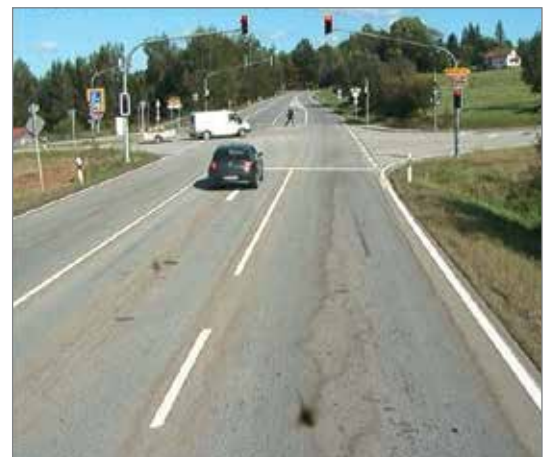
Measure

A separate left-turn phase “protects” road users turning left into the minor road from encountering oncoming traffic.

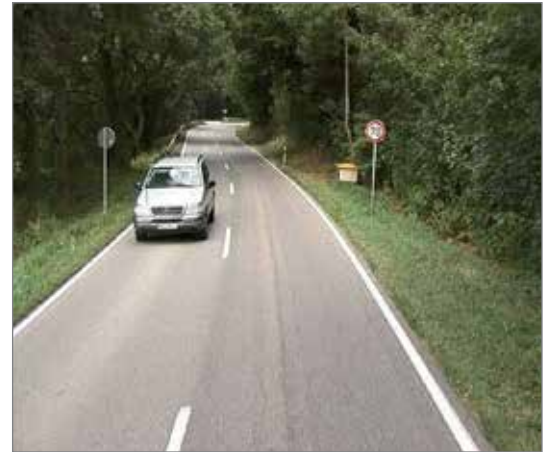
Measure

The speed limit reduces the speed level in the area of the bend

**BUT:** The direction of the bend must still be made clearer (e.g. by bend chevrons).

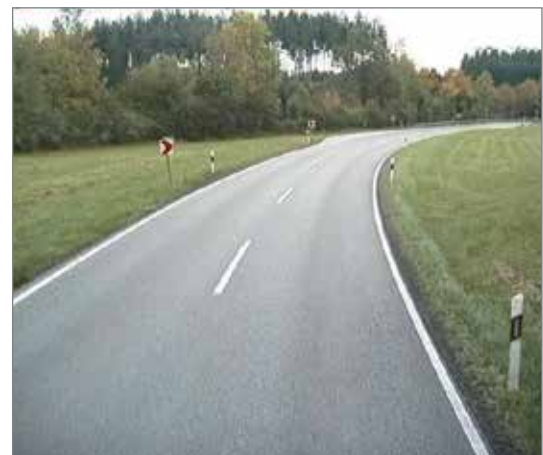
Measure

Individually placed bend chevrons indicate the direction of the bend.

**BUT:** The road is still in poor condition.

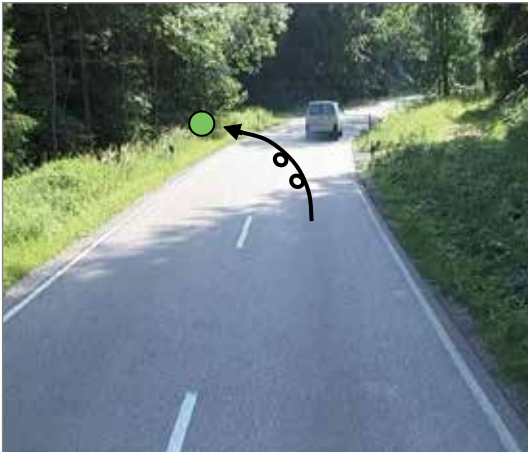
Problem

The direction of the bend was hard to see in the wooded area. In some areas visibility was limited due to sudden changes of light and dark patches, which promoted single-vehicle accidents.

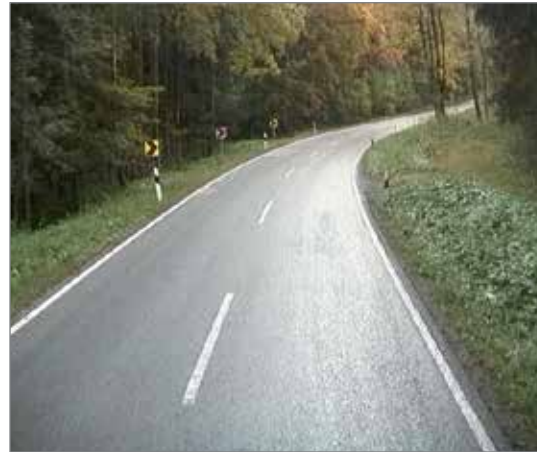
Measure

Individually placed bend chevrons (some of which are fluorescent yellow) indicate the direction of the bend.

**BUT:** Passive safety has not been increased (no steel crash barrier). In addition, visibility is still limited by the vegetation in the inner bend.

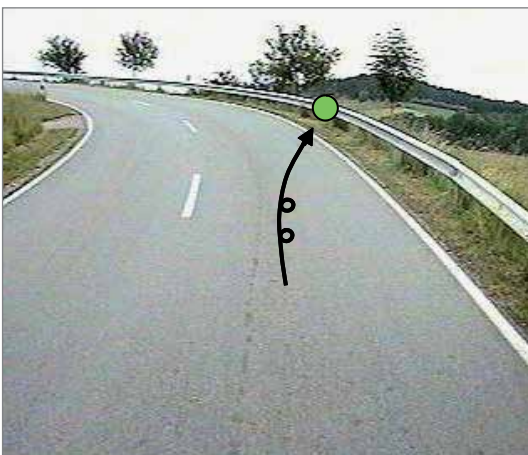
Problem

The direction of the bend was hard to see, which promoted single-vehicle accidents

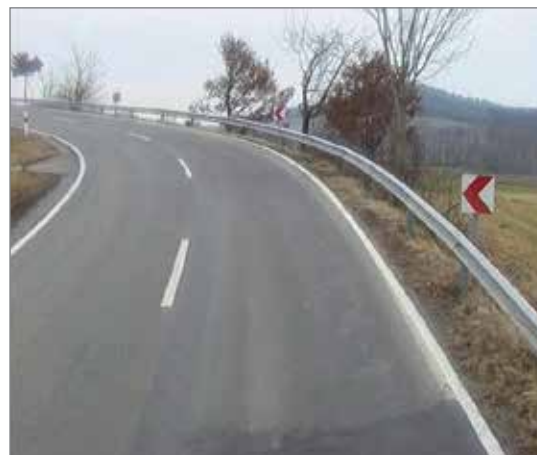
Measure

Individually placed bend chevrons indicate the direction of the bend.

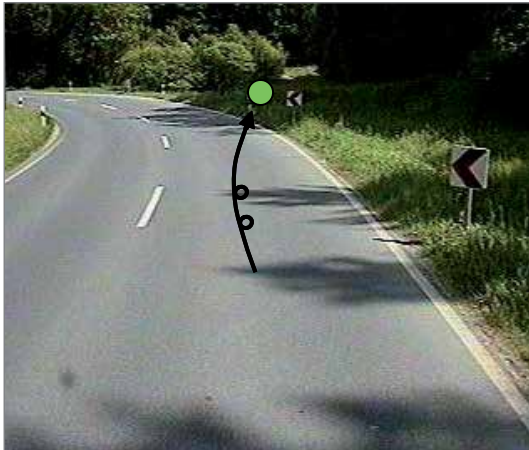
Problem

The direction of the bend was hard to see despite (some) individually placed bend chevrons, which promoted single-vehicle accidents.

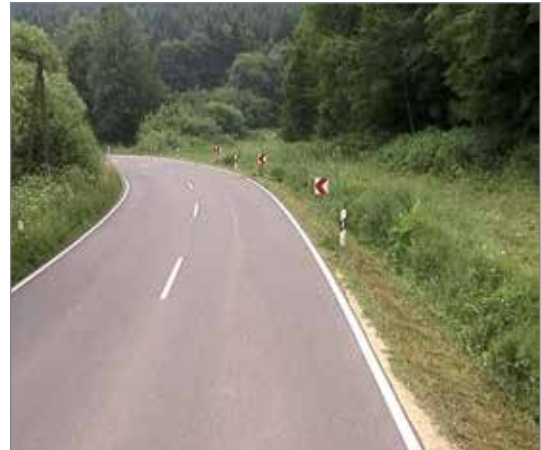
Measure

Additional individually placed bend chevrons make the direction of the bend clearer. **BUT:** Visibility is still limited by the vegetation in the inner bend.

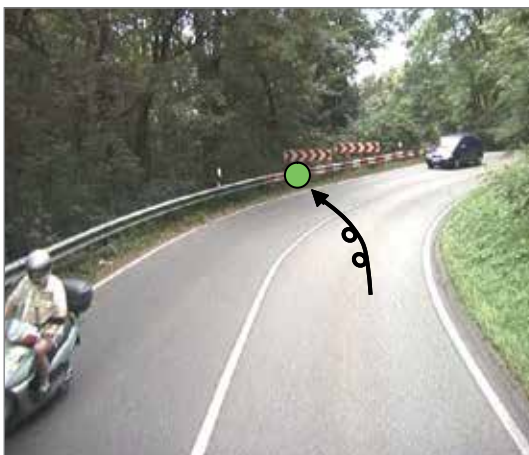
Problem

The traffic guidance equipment was insufficient to indicate the direction of the bend, which promoted single-vehicle accidents.

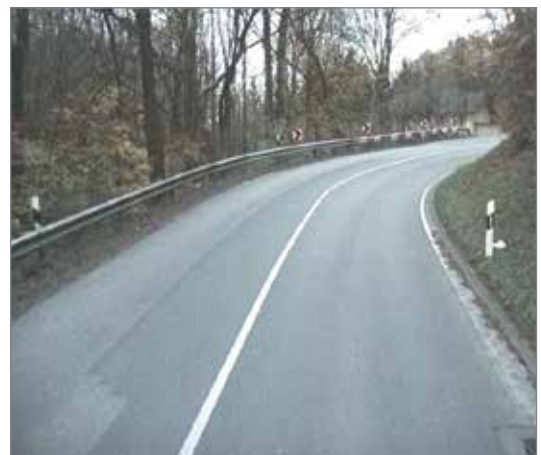
Measure

Individually placed bend chevrons indicate the direction of the bend on an extended stretch of road. **BUT:** Visibility is still limited by the slope in the inner bend.

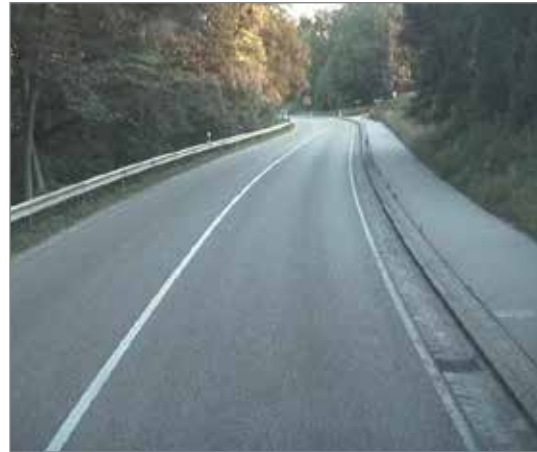
Measure

The solid line centre road marking makes the course of the road and the lane limits clearer. In addition, overtaking is banned.

**BUT:** The safety distance between the road and the attached pavement and bicycle path is insufficient.

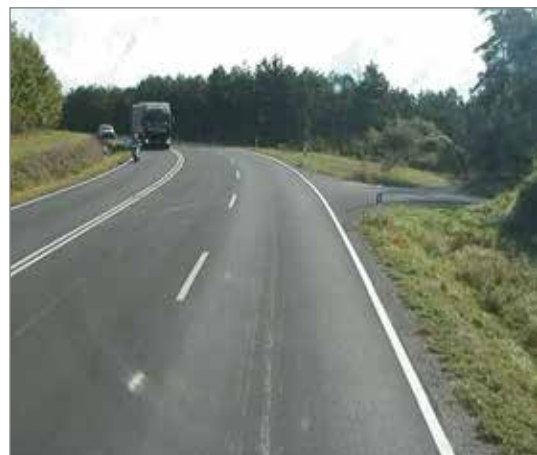
Measure

The double solid line centre road marking makes the lane limits, the course of the road and the three-lane, single-carriageway layout of the road clearer.

**BUT:** The at-grade access remains.

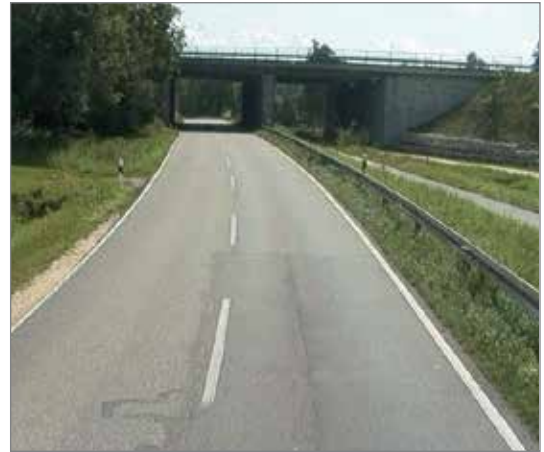
The renewed centre road marking makes the course of the road clearer.

**BUT:** This measure could not improve the limited field of vision caused by the bridge.

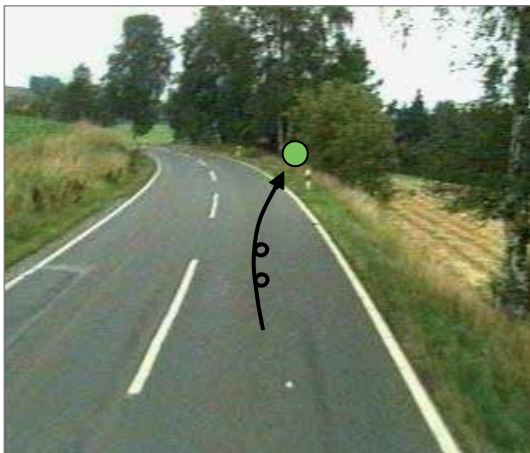
Problem

The direction of the bend was hard to see. In addition, there were trees at the edge of the road. Single-vehicle accidents where vehicles collided with the trees in the outer bend had severe consequences.

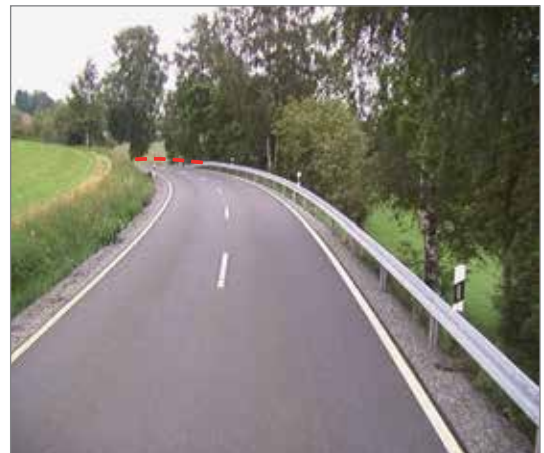
Measure

Passive safety was increased by means of a steel crash barrier.

**BUT:** The length of the steel crash barrier is insufficient (unprotected trees farther on in the bend). In addition, the bend direction must still be made clearer.

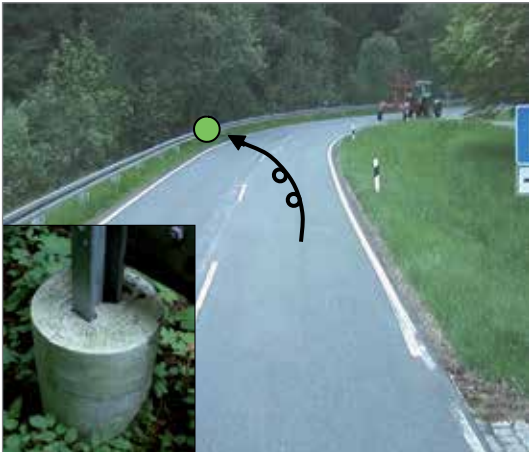
Problem

The road's layout was discontinuous and the marking was hard to see. Motorcycle single-vehicle accidents involving a collision with the posts of the steel crash barrier resulted in severe consequences despite the posts' protective casing.

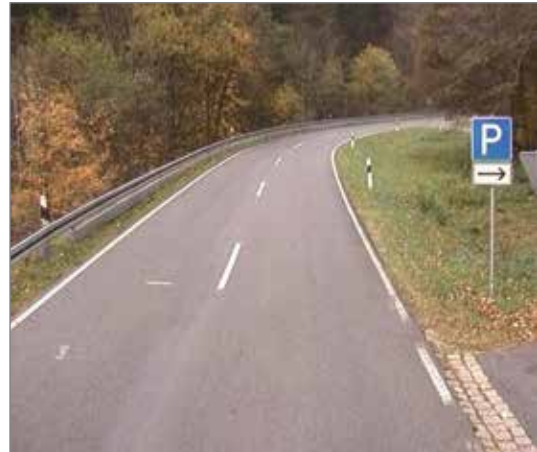
Measure

Passive safety for motorcycle riders was increased by means of an underrun protection. **BUT:** The edge marking is still in need of improvement.

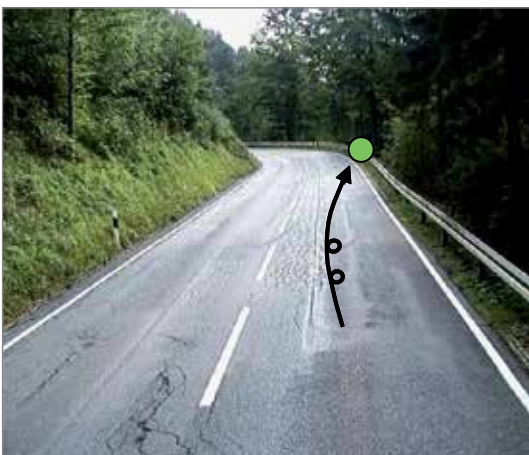
Problem

The road was in a very poor condition. In addition, it was very hard to identify the direction of the bend, which repeatedly resulted in single-vehicle accidents.

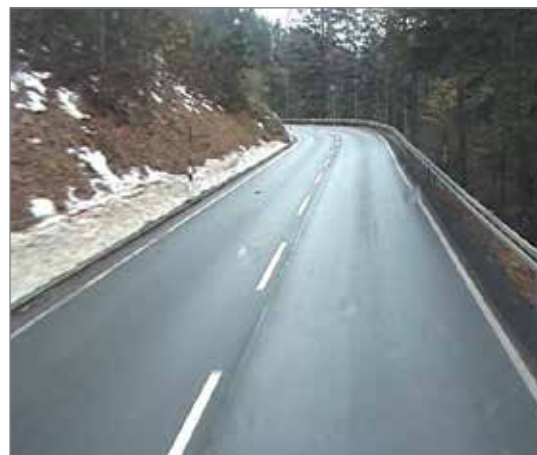
Measure

Thanks to the renewed wearing course, the road is again in a good condition. **BUT:** Visibility is still very limited due to the slope in the inner bend.

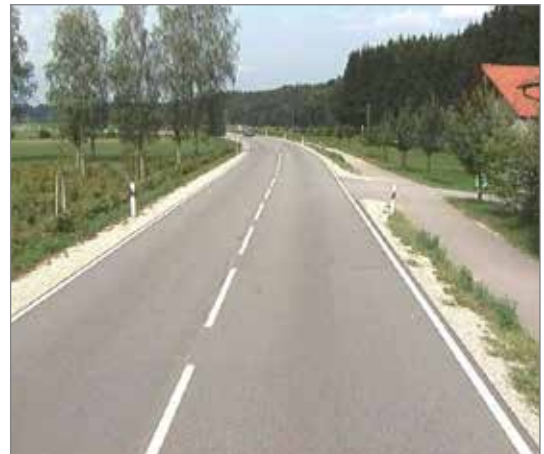
Measure

Thanks to the extension work based on the existing structure, the road is safe for traffic again. **BUT:** The vegetation in the inner bend is still limiting visibility. In addition, the safety distance between the road and the attached bicycle path is insufficient.

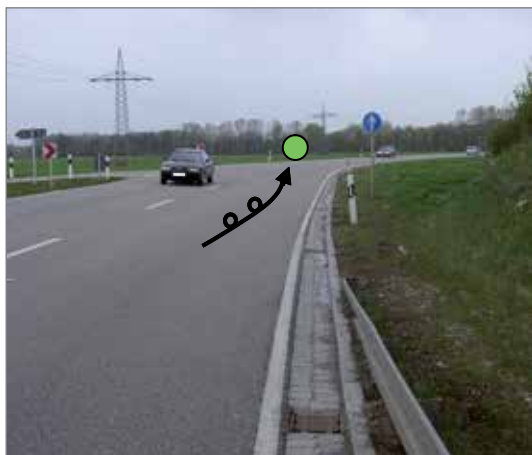
Problem

Both the radius and the transverse slope decreased suddenly in the bend, which resulted in an accumulation of single-vehicle accidents.

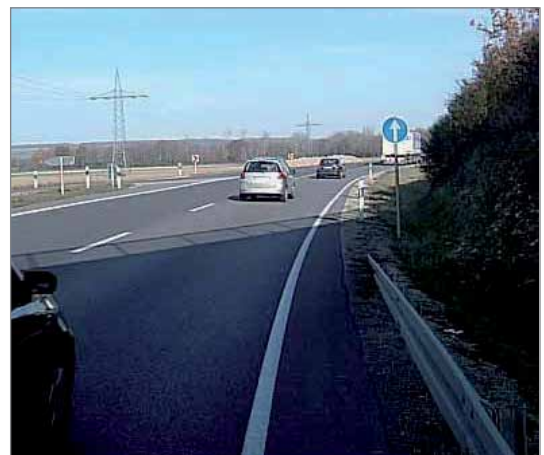
Measure

The new layout of the right road edge with a continuous radius and an increased consistent transverse slope eliminated the accident hotspot.

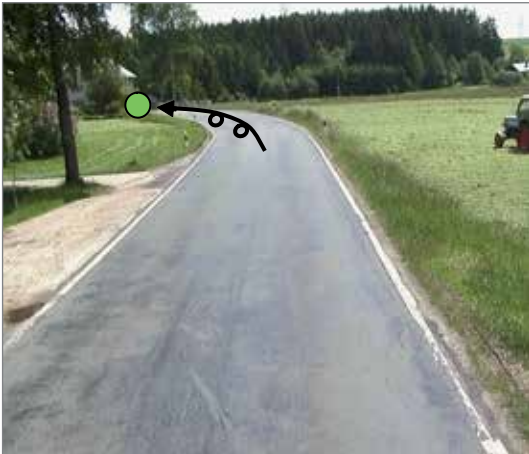
Problem

The turning line and the further course of the road towards the right could not be anticipated. Numerous drivers lost control of their vehicles for this reason.
