## Accident Blackspots on Rural Roads

## Safety Measures

## Effectiveness

Version 2011

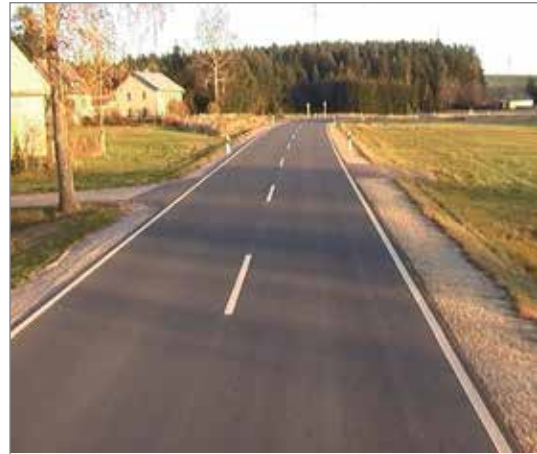
Measure

A bend was removed in the new road layout to make the further course of the road towards the right clear. In addition, the cross-section was widened, the road was resurfaced and its marking was renewed.

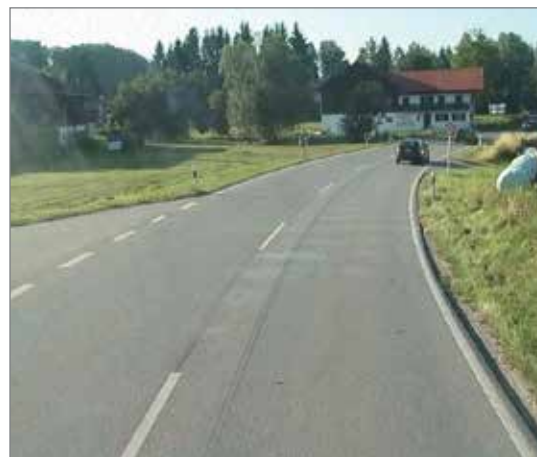
Measure

The area at the road edge which is now free of obstacles provides a large zone for vehicles to come to a standstill. The destination signs were only installed later on.

**BUT:** The soft shoulder is still in poor condition.

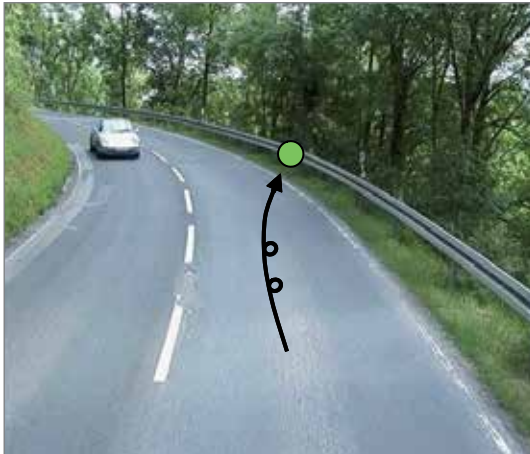
Problem

The tight radius of the bend was hard to see, which promoted single-vehicle accidents.

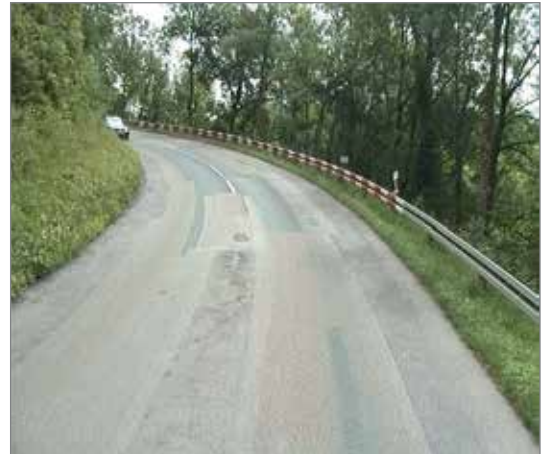
Measure

Traffic guidance equipment installed on top of the steel crash barrier makes it easier to see the direction of the bend.

**BUT:** The marking and the condition of the road are still deficient.

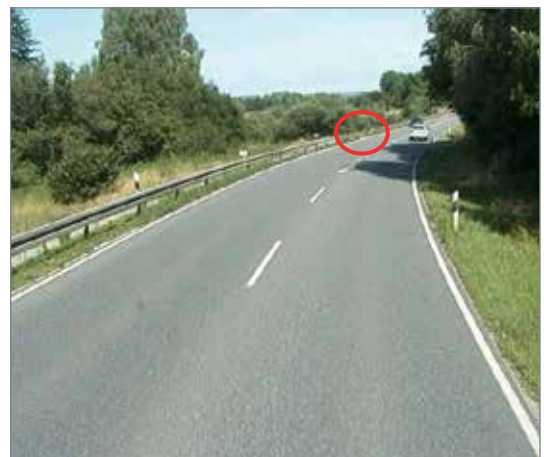
Measure

Thanks to the new wearing course, the road has more grip. In addition, the type II marking provides increased night-time visibility.

**BUT:** The steel crash barrier has a gap.

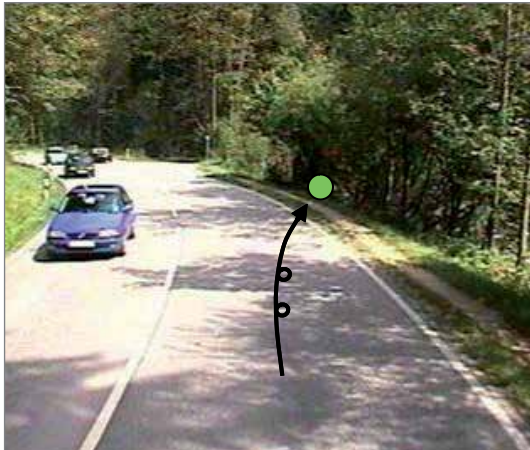
Problem

The road layout was discontinuous. In addition, there were trees at the edge of the road. The direction of the bend was hard to see, which promoted single-vehicle accidents that had severe consequences where vehicles collided with the trees.

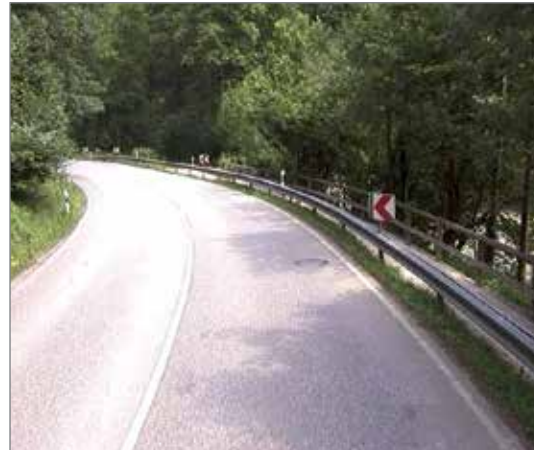
Measure

Individually placed bend chevrons indicate the direction of the bend. When a vehicle departs from the road, steel crash barriers prevent it from colliding with a tree which might have severe consequences.

**BUT:** The vegetation in the inner bend still limits its visibility.

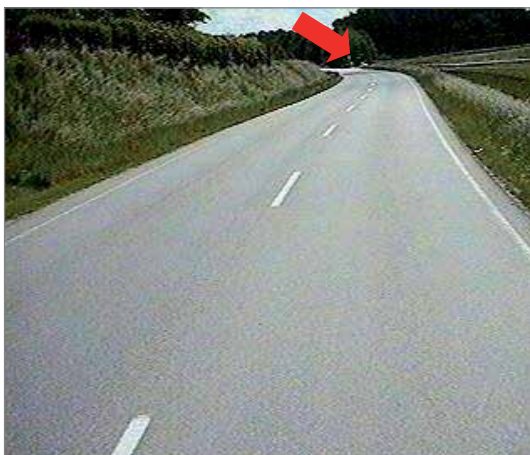
Problem

The intersection situated in the bend was hard to see. Drivers could therefore only react to the new traffic situation when they had already approached the intersection, which promoted single-vehicle accidents.

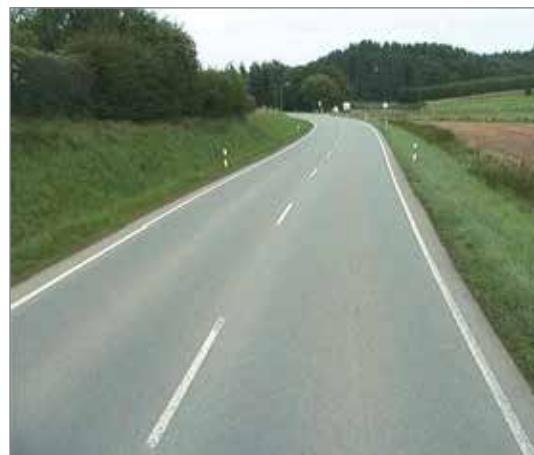
Measure

The flatter slope improves visibility and makes it therefore easier for the drivers in the main flow to see the course of the road, including the intersection.

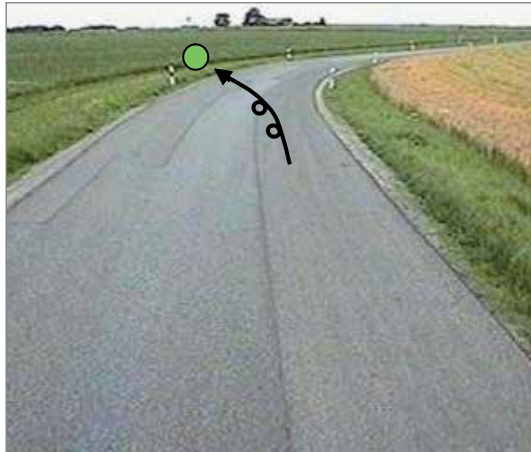
Problem

Due to the lack of marking it was hard to see the direction of the bend, especially at night, which promoted single-vehicle accidents.

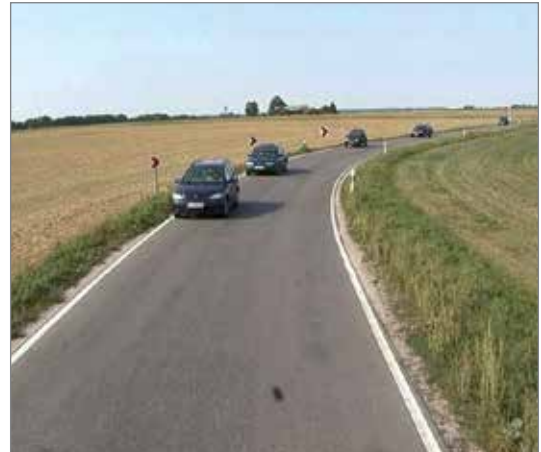
Measure

Individually placed bend chevrons and renewed road edge markings indicate the direction of the bend.

**BUT:** The vegetation on the soft shoulder has to be cut back regularly.

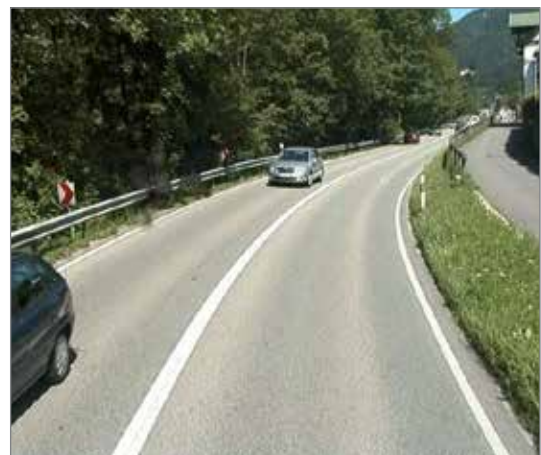
Thanks to a qualified renewal of the wearing course with an increase of the transverse slope the road now features good grip and drainage conditions again.

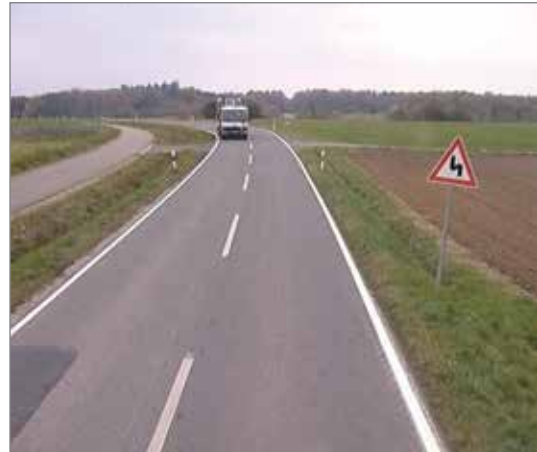
Measure

The danger sign gives advance warning of the double bend.

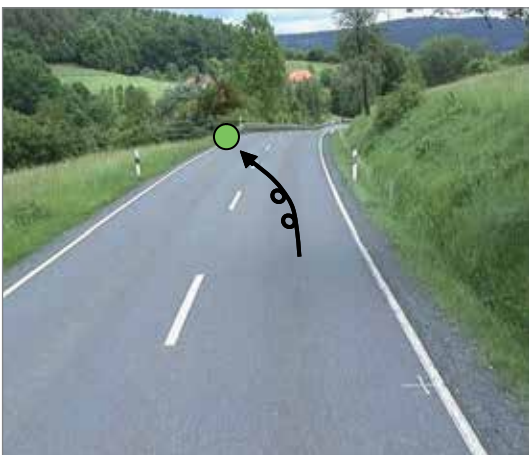
Problem

The layout of the road was discontinuous and the road sometimes dipped down, which promoted single-vehicle accidents.

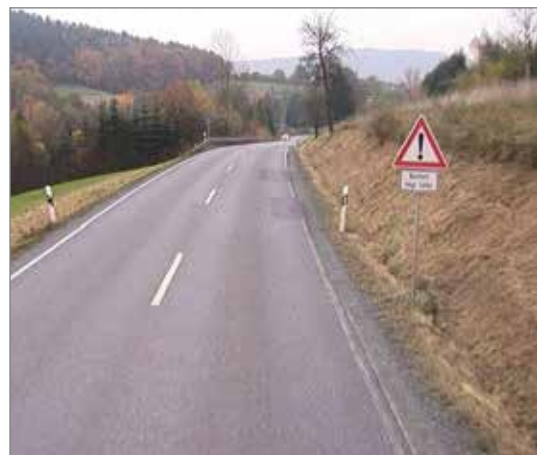
Measure

The danger sign gives advance warning of the dangerous layout of the road (additional sign installed later on).

**BUT:** The condition of the soft shoulder is in need of improvement.

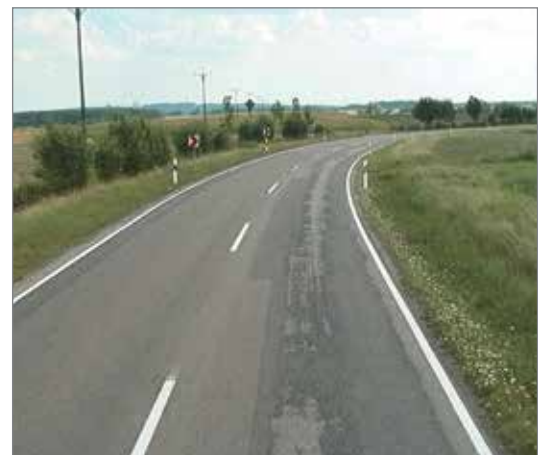
The course of the road was hard to see which is why the curvature of the road was underestimated. This repeatedly caused accidents involving longitudinal traffic (rear-end and head-on collisions) when overtaking.

Individually placed bend chevrons indicate the course of the road and thus reduce the willingness to overtake.

**BUT:** The road is still in poor condition.

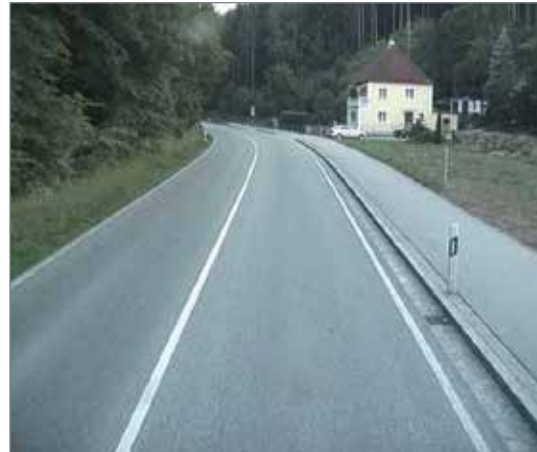
Visibility was not sufficient for overtaking. Due to overtaking manoeuvres performed despite insufficient visibility, accidents involving longitudinal traffic (rear-end and head-on collisions) occurred repeatedly.

The solid line centre road marking prohibits overtaking.  
**BUT:** The safety distance between the road and the attached pavement and bicycle path is still insufficient.

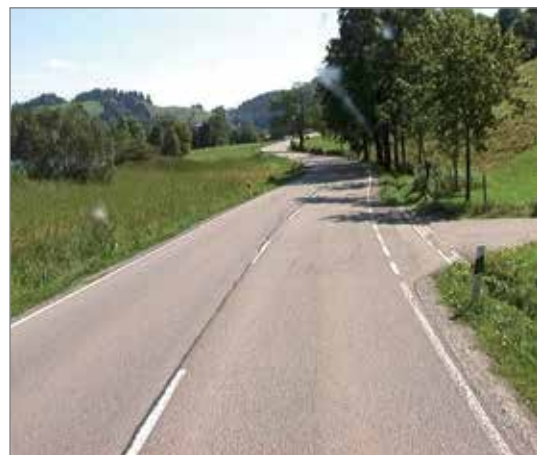
Visibility for overtaking was limited by a tree at the edge of the road. Due to overtaking manoeuvres accidents involving longitudinal traffic (rear-end and head-on collisions) occurred repeatedly.

Visibility was improved by removing the obstacle (tree).  
**BUT:** Passive protection (trees in outer bend unprotected) and the markings are still not ideal.

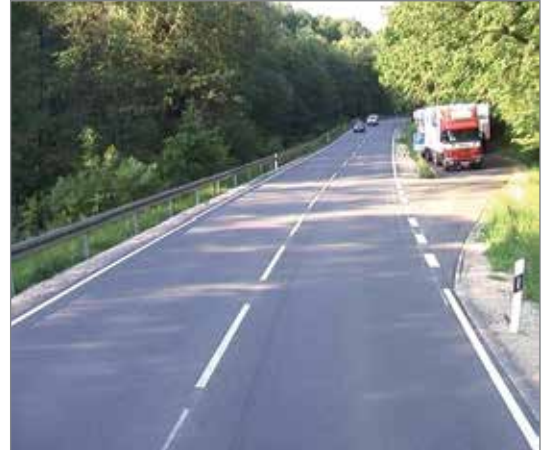
The road was in a poor condition, which promoted rear-end collisions when the road was wet.

Thanks to the renewal of the wearing course, the road's grip level is satisfactory again.

**BUT:** It is still possible to leave the parking area (against the direction of the traffic).

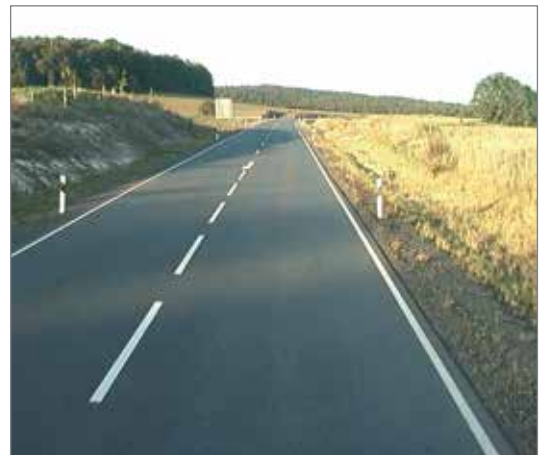
The direction of the bend (turning line) was hard to see. Overtaking manoeuvres in the area of the bend resulted in head-on collisions with severe consequences.

The changed layout of the road has no turning line and makes the further course of the road towards the right clear.

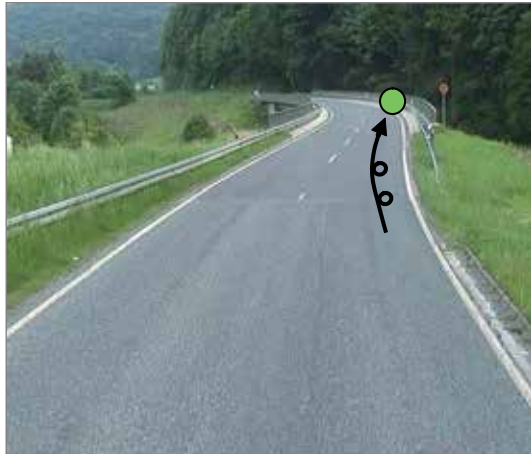
The course of the road was hard to see. High speeds led to single-vehicle accidents.

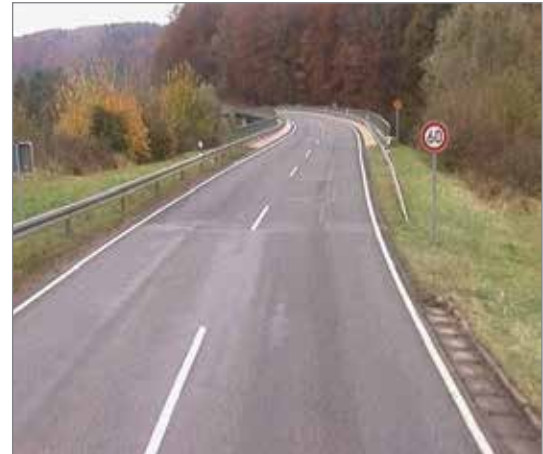
The speed limit reduces the speed level before the critical section of the road. In addition, the road surface beyond the accident blackspot was repaired.

**BUT:** Due to the vegetation in the inner bend and the bridge railing it is still hard to see the course of the road.

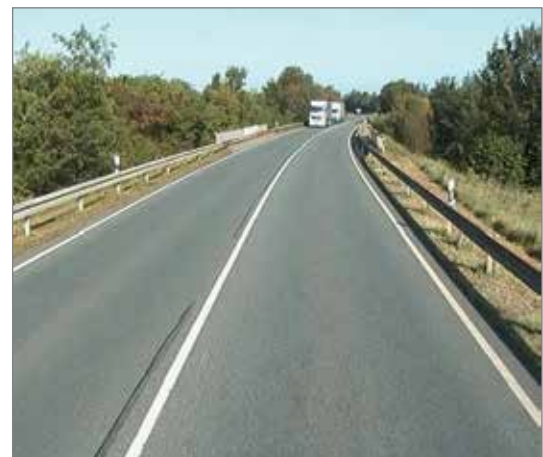
The straight layout of the road incited drivers to drive very fast (speeding). However, visibility was insufficient for overtaking due to the vegetation and the steel crash barrier, which resulted in single-vehicle accidents when overtaking.

The solid line centre road marking prohibits overtaking and thus reduces the speed level.

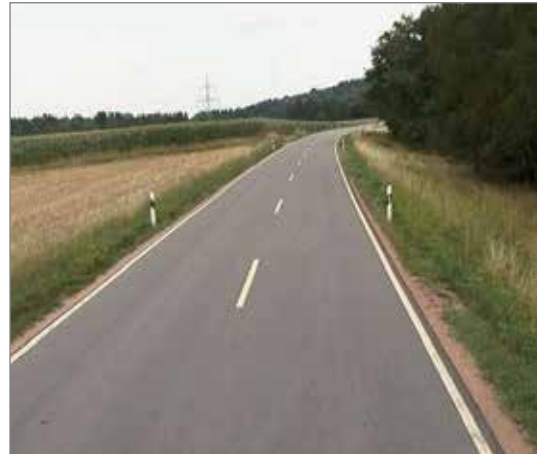
The road was in a very poor condition, which promoted single-vehicle accidents.

Thanks to the renewed wearing course, the road is again in a mostly safe condition.  
**BUT:** Visibility is still very limited due to vegetation in the inner bend.

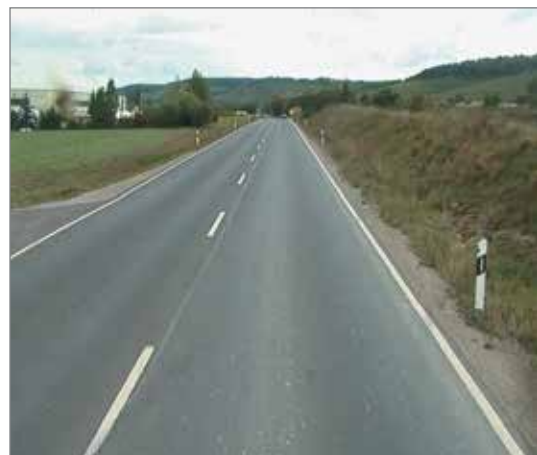
The condition of the road suddenly deteriorated at the end of the extension work, which promoted single-vehicle accidents.

Since the extension work has been continued the quality standards are adhered to throughout the entire road section.

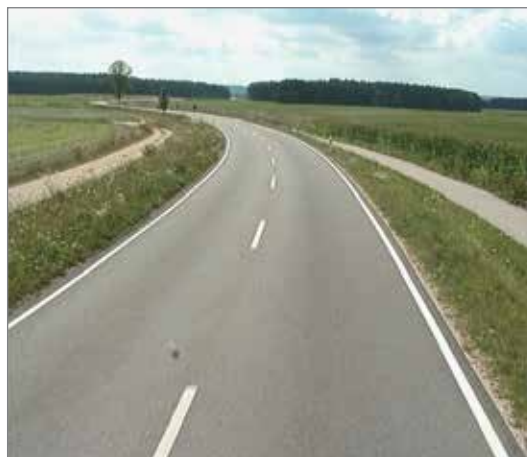
The layout of the road was discontinuous and the road was very narrow, which promoted single-vehicle accidents.

During the extension of the section according to the regulations, the cross-section of the road has been widened and the layout of the road has been improved. The bicycle paths running parallel to the road also increase road safety.

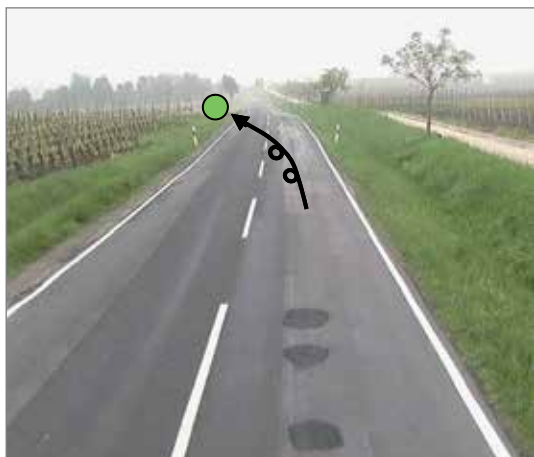
The road was in a poor condition and the layout of the road was discontinuous. As the road sloped up, the course of the road behind the slope was hard to see, which promoted single-vehicle accidents.

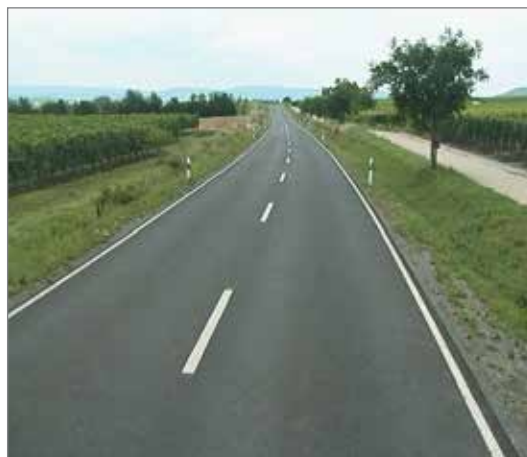
The position and elevation of the course of the road have been significantly improved during the extension of the section according to the regulations.

**BUT:** Passive safety has not been improved (still trees at the edge of the road).

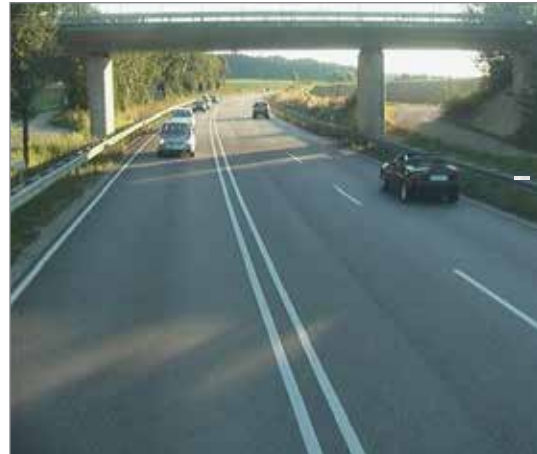
The straight layout of the road incited drivers to drive very fast. However, visibility was insufficient for overtaking due to the bridge. Aborted overtaking manoeuvres caused drivers to lose control of their vehicle.

The addition of another lane provides for safe overtaking.

**BUT:** Traverse slope, radiuses and connecting intersections must be adapted to the requirements of driving dynamics.

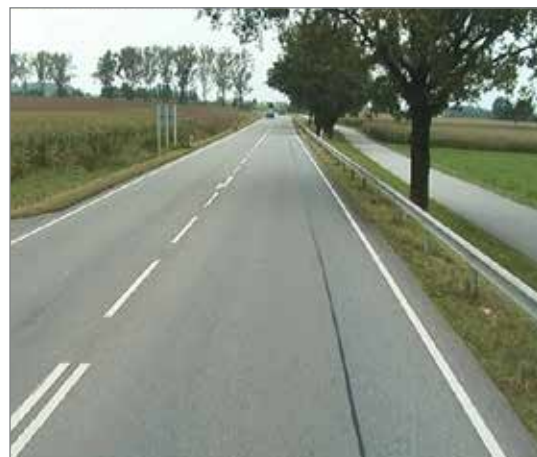
Passive safety was increased by installing a steel crash barrier. This also increased the protection of cyclists on the bicycle path running parallel to the road.

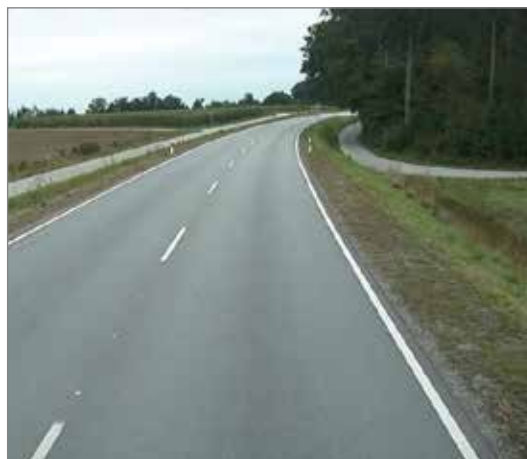
The layout of the road was discontinuous. In addition, this section of the road had numerous access roads and junctions, which promoted risky overtaking manoeuvres of turning vehicles travelling at lower speeds.

Since the extension of the section according to the regulations, the agricultural road network has been reorganized and the access roads have been merged so that only a few junctions remain.

**BUT:** The vegetation in the inner bend still limits its visibility.

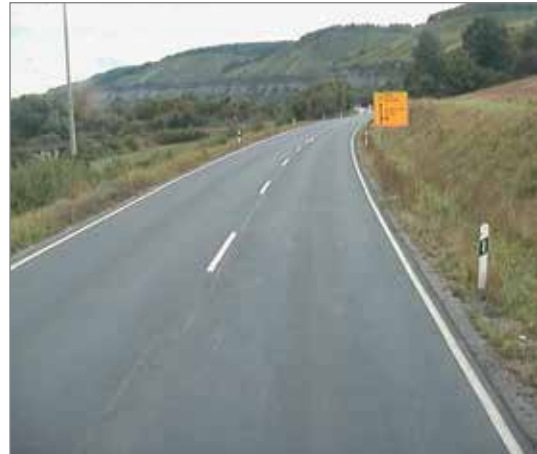
The road was in a poor condition, which promoted rear-end collisions when the road was wet.

Thanks to the extension work based on the existing structure the road is safe for traffic again.

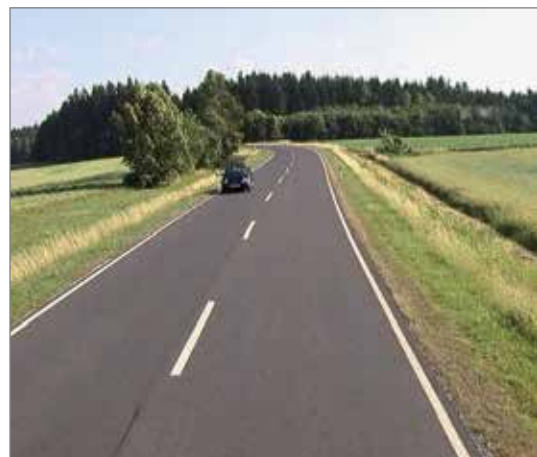
The layout of the road was discontinuous and the road was in a poor condition, which promoted rear-end collisions when the road was wet.

Thanks to the renewed wearing course, the road provides sufficient grip again.

**BUT:** The discontinuous layout of the road has not been improved by the renewed wearing course.

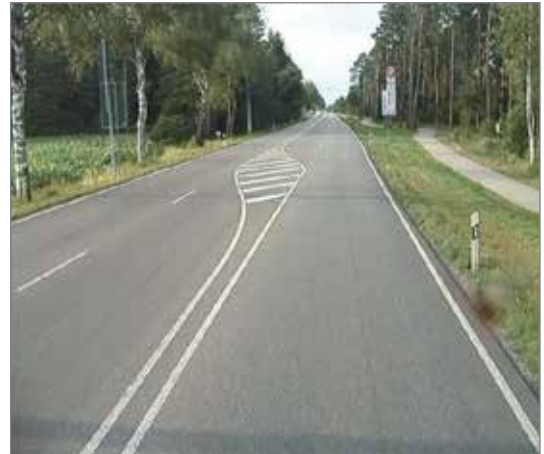
The road provided little opportunities for overtaking while the volume of traffic was quite high. Overtaking despite short time gaps in incoming traffic repeatedly caused severe accidents involving longitudinal traffic (rear-end and head-on collisions).

The addition of another lane provides for safe overtaking.

**BUT:** Although the speed level has now increased, passive safety has not been improved (still trees at the edge of the road).

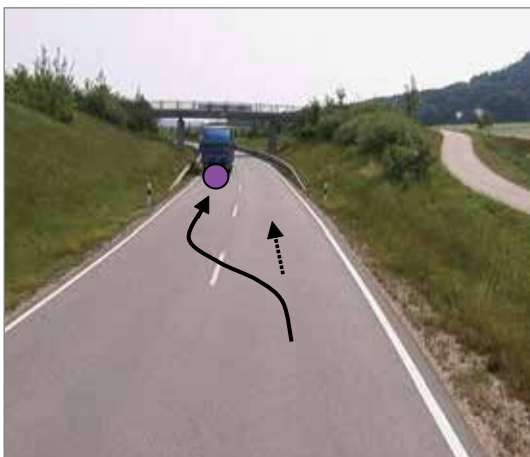
Visibility was insufficient for overtaking due to the slope and the bridge. However, drivers performed overtaking manoeuvres despite insufficient visibility, which caused severe accidents involving longitudinal traffic (rear-end and head-on collisions).

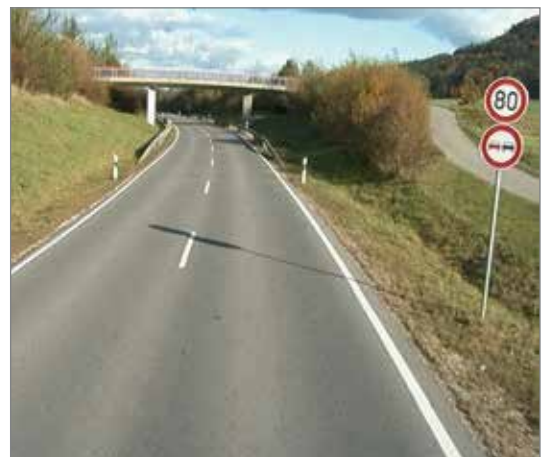
The ban on overtaking prohibits overtaking in the area of the bend. The speed limit reduces the speed level.

**BUT:** Visibility is still limited.

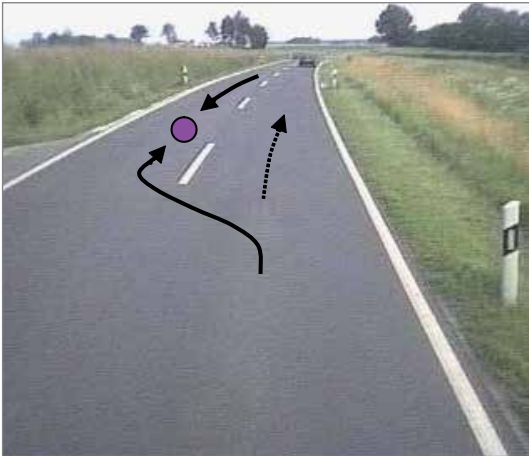
Due to the vegetation at the edge of the road visibility was not sufficient for overtaking, which frequently caused accidents involving longitudinal traffic (rear-end and head-on collisions) during overtaking manoeuvres.

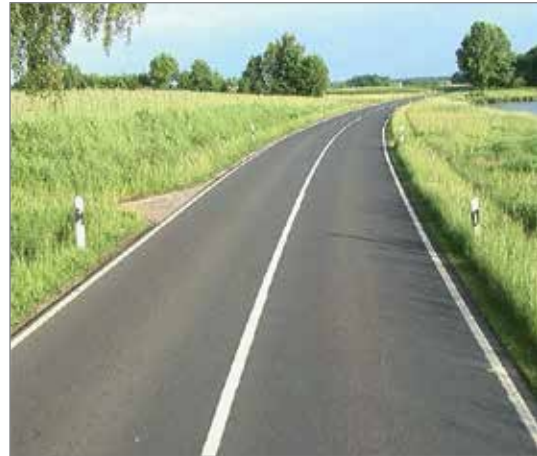
The solid line centre road marking prohibits overtaking.

**BUT:** The vegetation on the soft shoulder must be cut back at regular intervals.

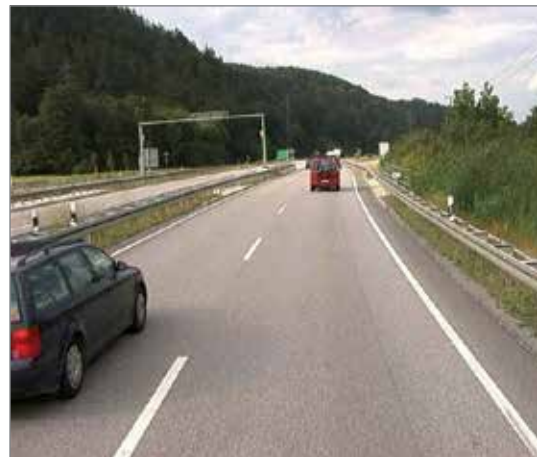
The extension of the road to a dual carriageway separates the carriageways for opposite travelling directions and provides for safe overtaking and increases capacity.
